FORD:

2017 Escape

TSB 17-0032 (Continued)

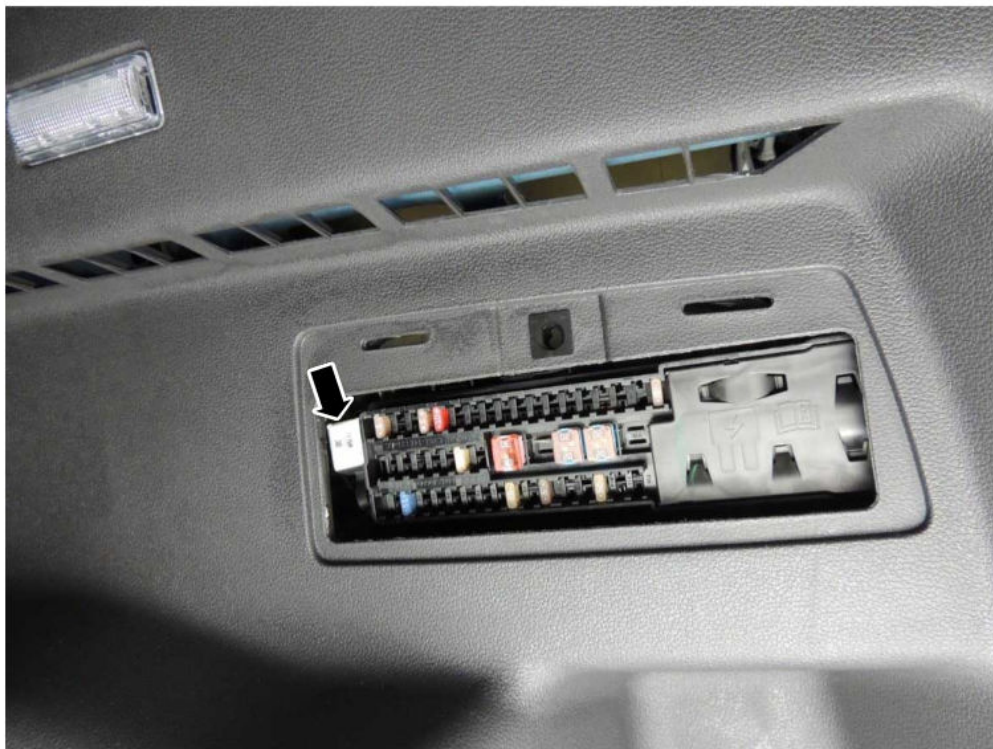
Figure 5 - Article 17-0032

Fuse 15 has been relocated to an inline fuse holder adjacent to the Rear Junction Box as highlighted in the figure below.

19. Reassemble the RJB by snapping the top cover on to the RJB housing, reinstall all the fuses and relays, excluding the original power window fuse F15.
20. Reinstall the relay cover by snapping it into place.
21. Reinstall the RJB on the body and secure with the nut.
22. To install, reverse the removal procedure for the right load space trim panel. Refer to WSM, Section 501-05.
23. Reconnect the negative battery cable. Refer to WSM, Section 414-01.
24. Print and insert the Customer Information Sheet with the revised power window fuse 15 location into the Owner's Manual. (Figure 5)
