FORD:

2015-2017 Edge

2016-2017 MKX

Some 2015-2017 Edge and 2016-2017 MKX vehicles may exhibit an exhaust odor in the vehicle while the climate control system is in auto or recirculation mode. Customers may indicate the odor smells like sulfur, or the exhaust odors are entering the vehicle cabin. This concern may be more pronounced after hard acceleration, driving in hilly conditions and/or towing a trailer. Whether and to what extent any occupant of these vehicles experiences the exhaust odor will be affected by driving habits, weather, and individual sensitivities

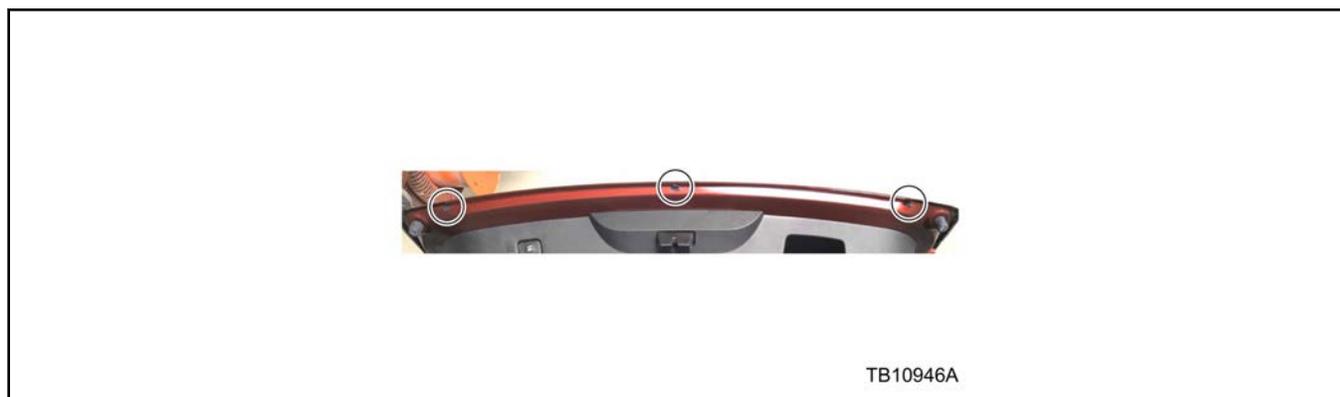
Figure 1 - Article 17-0035

1. Does the customer report an exhaust odor inside the vehicle under hard acceleration, towing a trailer, driving in hilly conditions or with the climate control system in auto or recirculate?
 - a. Yes - proceed to Step 2.
 - b. No - this article does not apply.
2. Check the rear doors are shut tightly and the edges are correctly aligned with the rear quarter panel. Adjust the door striker as needed. Refer to Workshop Manual (WSM), Section 501-03.
3. Visually inspect the rear liftgate weatherstrip seal for proper seating to the body of the vehicle.
4. Check the weatherstrip contact mark around the entire liftgate to make sure the liftgate is correctly aligned. Reposition the liftgate as required to obtain a proper seal. Refer to WSM, Section 501-03.
5. Make sure the liftgate drain plugs are installed correctly on the liftgate. Reposition as required.
 - a. MKX (Figure 1)

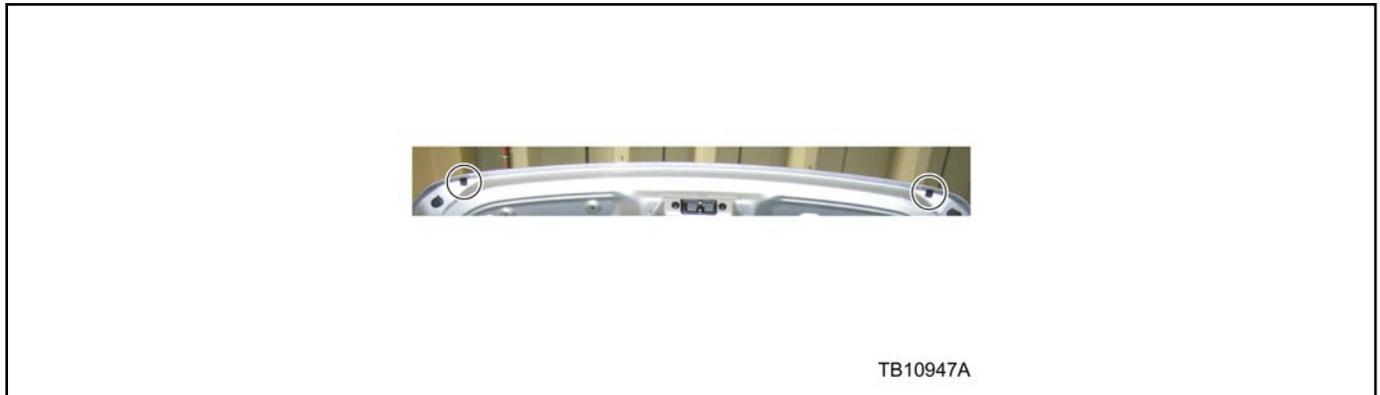
Figure 2 - Article 17-0035

b. Edge (Figure 2)

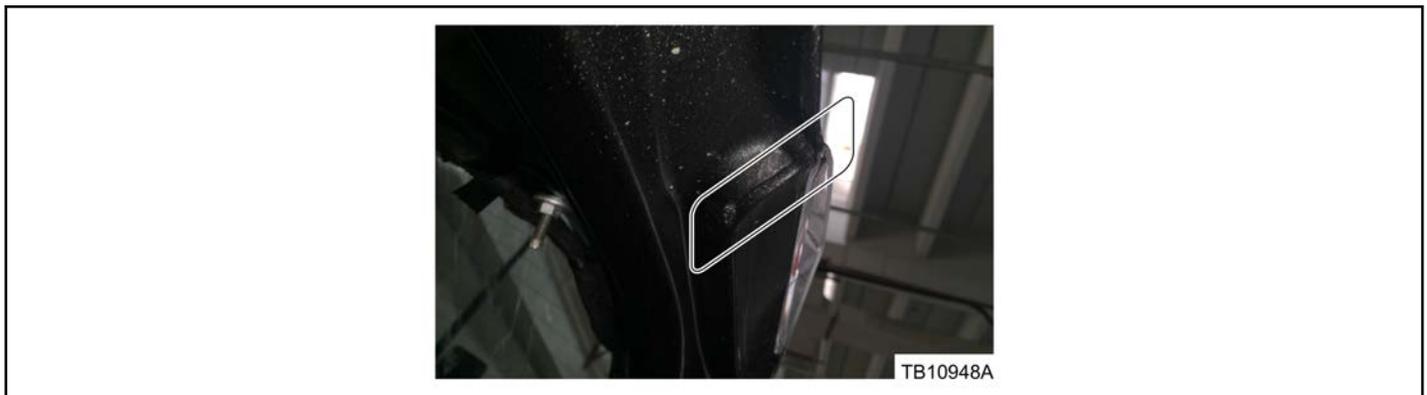
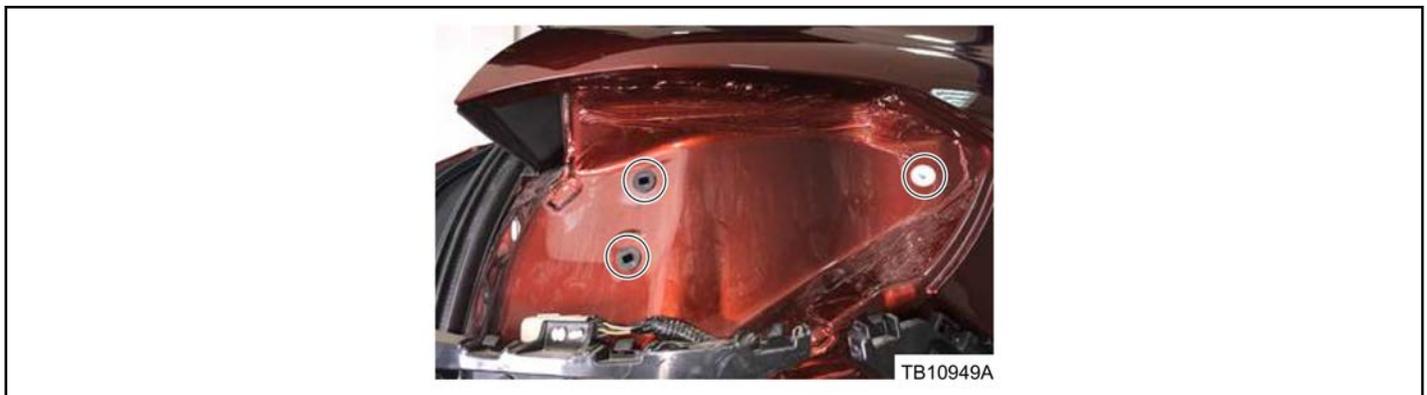
6. Remove the left and right rear lamp assemblies. Refer to WSM Section 417-01.
7. Inspect the horizontal and vertical surfaces of the rear tail lamp assembly mounting area for holes or gaps in the body sealer. If any holes or gaps are found, seal with Motorcraft® Seam Sealer or equivalent.
8. Verify all rear tail lamp assembly body plugs, plastic anchor nuts and wiring grommets are fully seated against the body. (Figures 3 - 4)

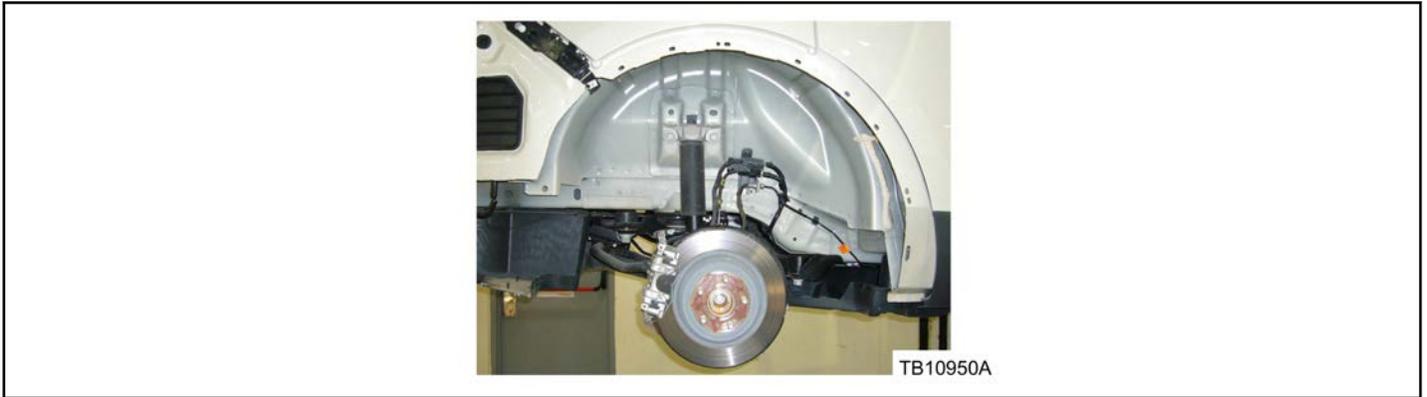
Figure 5 - Article 17-0035

9. On the MKX, remove the right and left rear quarter panel moulding. Refer to WSM, Section 501-08.
10. Remove the rear bumper cover. Refer to WSM, Section 501-19.
11. Remove the right and left rear quarter panel inner wheel liner. (Figure 5)

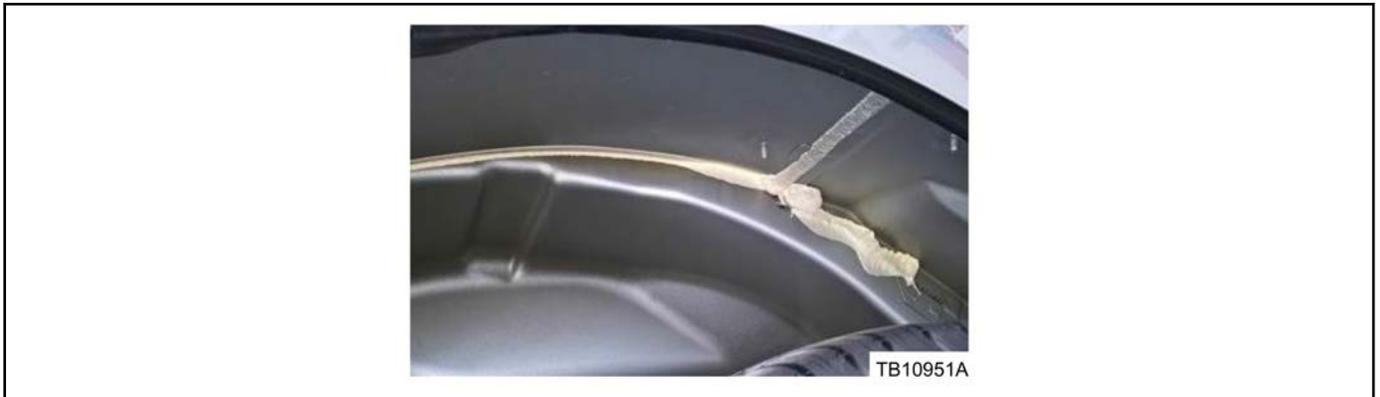
Figure 6 - Article 17-0035

12. Inspect the entire length of the joined inner fender panels for large, obvious panel gaps or body sealer gaps. Closely inspect for gaps in the following areas. If any gaps are found, seal with Motorcraft® Seam Sealer or equivalent.
- a. Lower arch edge.
 - b. Upper edge of the wheel arch. (Figure 6)

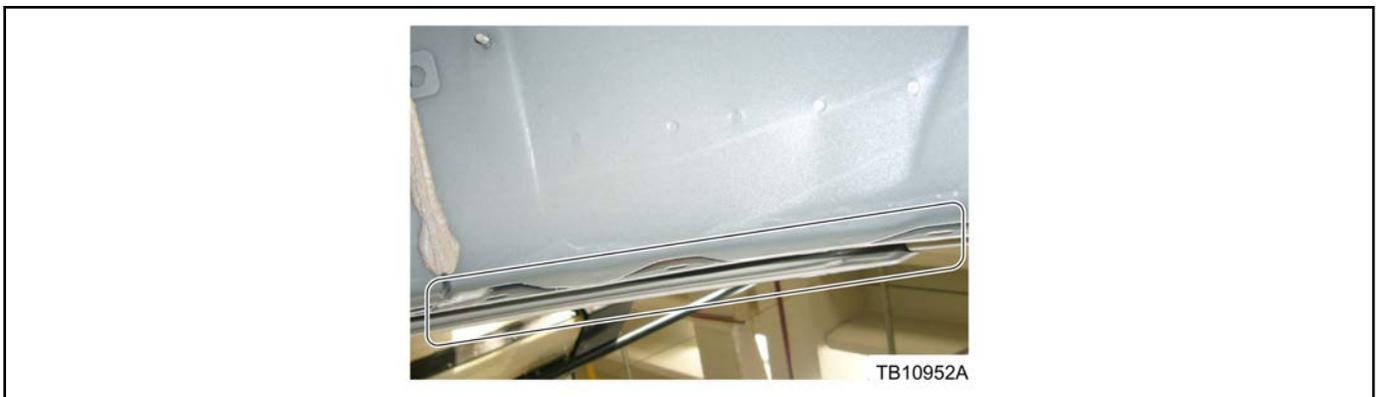
Figure 7 - Article 17-0035

- c. Upper wheel arch area, from the back, where the outer and inner body panels meet. (Figure 7)

- f. Check the rear inner fender panel seams and body sealer applications for air leaks, especially at the top of the wheel arch and at the lower edges. (Figure 7)

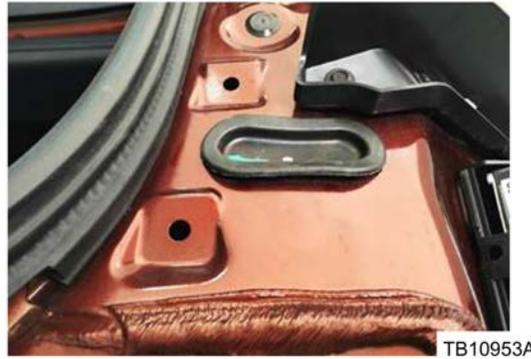
Figure 8 - Article 17-0035

13. Check that all rear body plugs and plastic anchor nuts located beneath the bumper cover are fully seated against the body. (Figure 8)

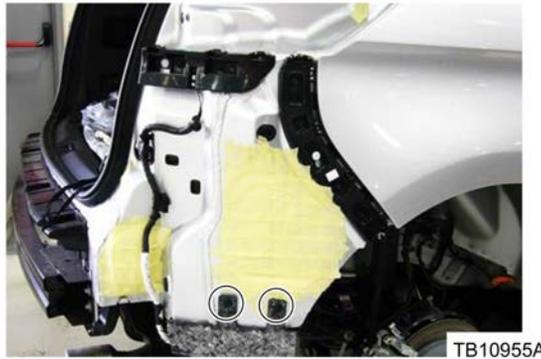
Figure 9 - Article 17-0035

14. Make sure the two plastic pushpins used to attach the sound insulation piece to the lower edge of the body are fully seated. (Figure 9)

17. Prepare the vehicle for a cabin pressurization test.
 - a. Use masking tape to cover all air extractors and any open bolt holes located behind the rear bumper cover. (Figure 9)
 - b. Cover the license plate anchor nuts by installing the license plate screws or tape over them.
18. After waiting 1 hour since the last seam sealer application to allow for dry time, start the vehicle, set the climate control to fresh air mode and set blower speed to maximum.
19. Close all doors and windows.
20. Using soapy water in a spray bottle, spray soapy water at suspected leak points on the vehicle. Note all leak areas identified by the presence of air bubbles.

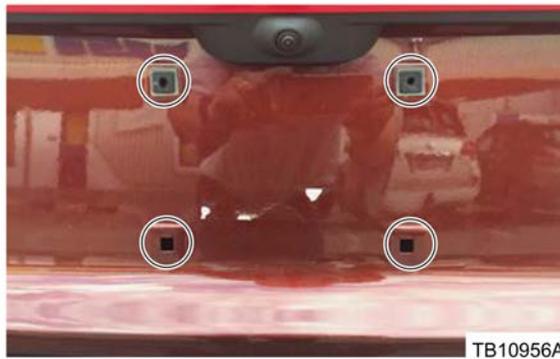
Figure 10 - Article 17-0035

15. Inspect the rear liftgate and verify that all four plastic license plate anchor nuts have been installed correctly. (Figure 10)

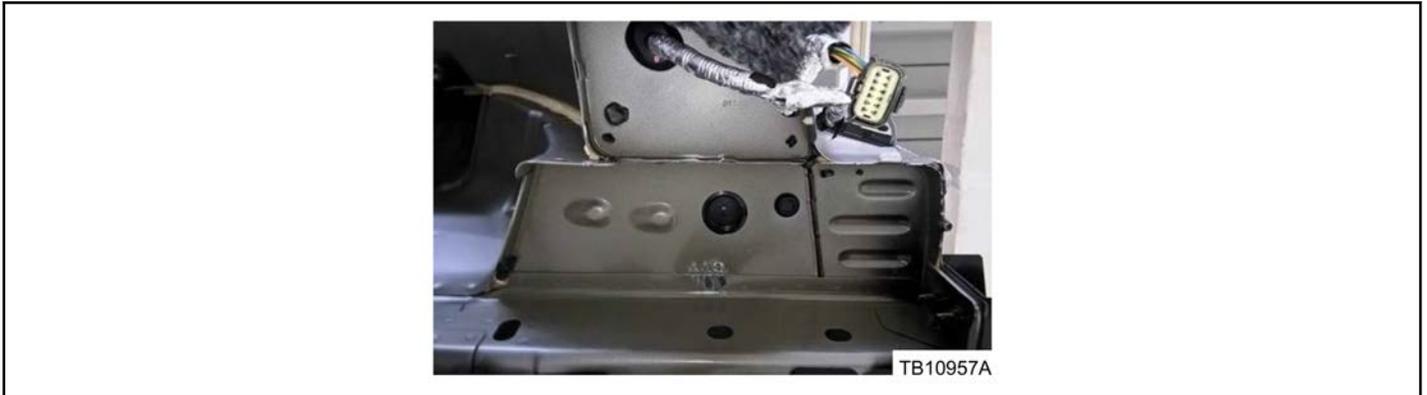
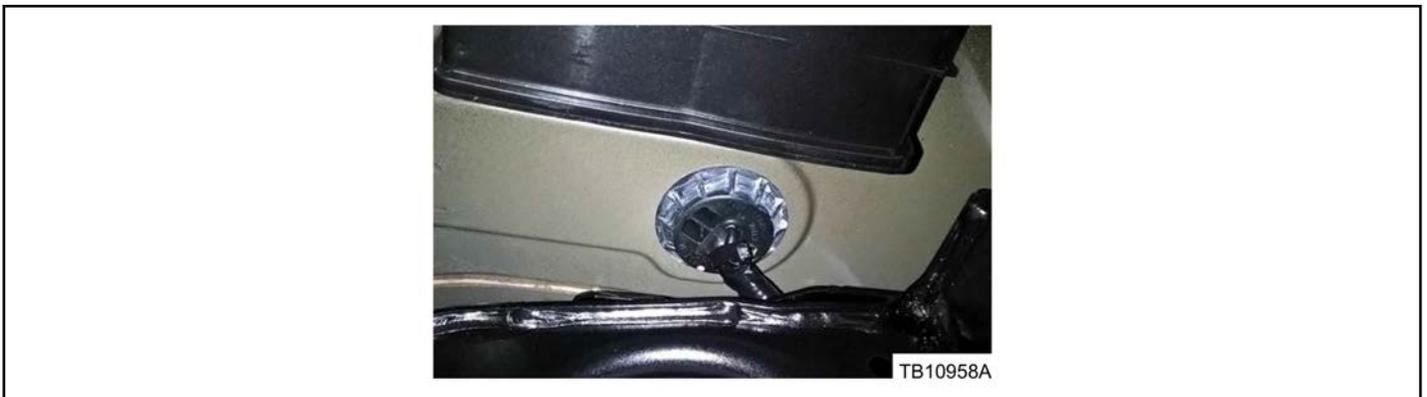
16. Raise the vehicle on the hoist and verify that all underbody plugs and grommets are fully seated. (Figure 11 - 12)

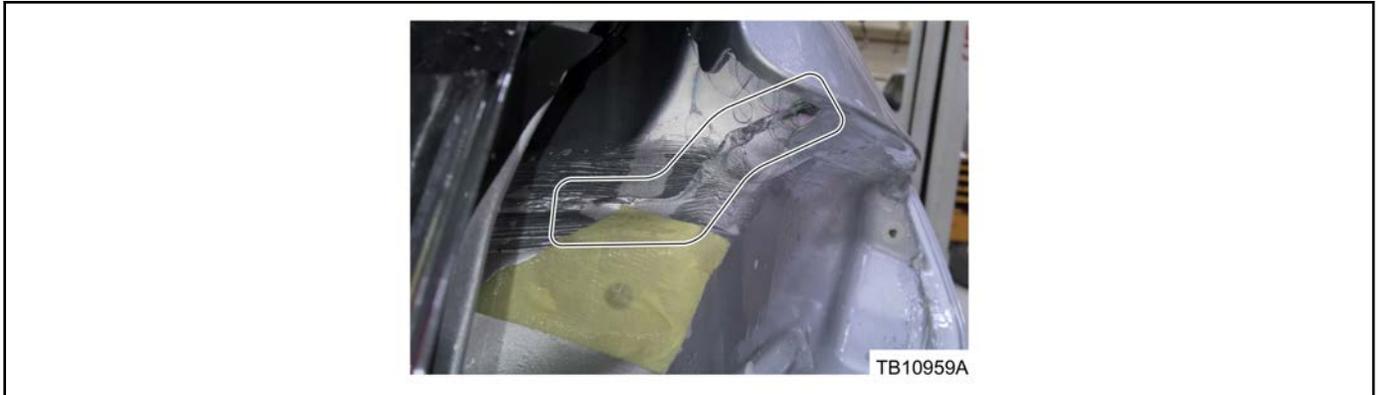
Figure 13 - Article 17-0035

- a. Inspect the tail lamp openings and check for leaks at the seams, in the body sealer, and around plastic grommets and mounting nuts. (Figure 13)

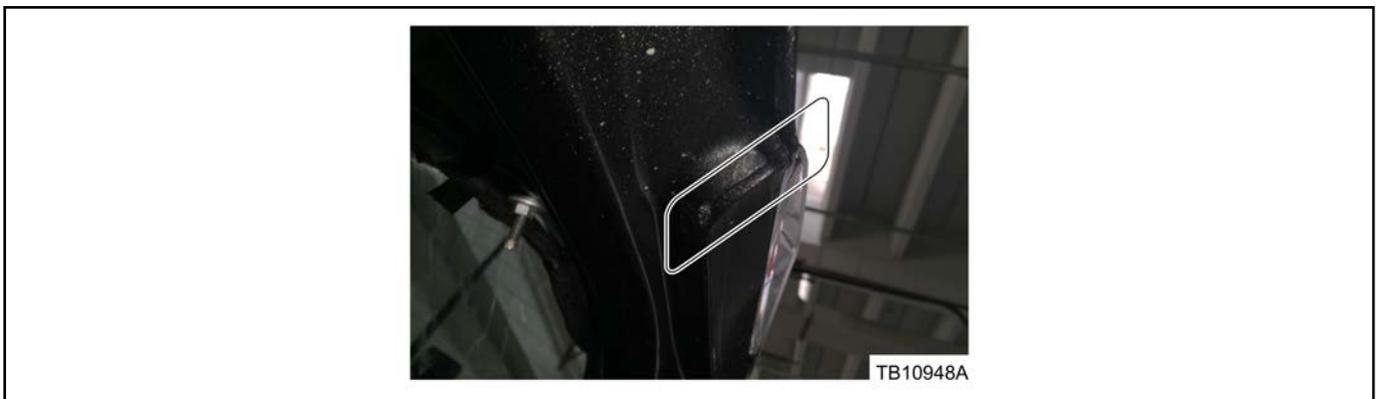
Figure 14 - Article 17-0035

- b. Inspect the area of the liftgate that meets the tail lamps for air leaks along the panel seams. (Figure 14)

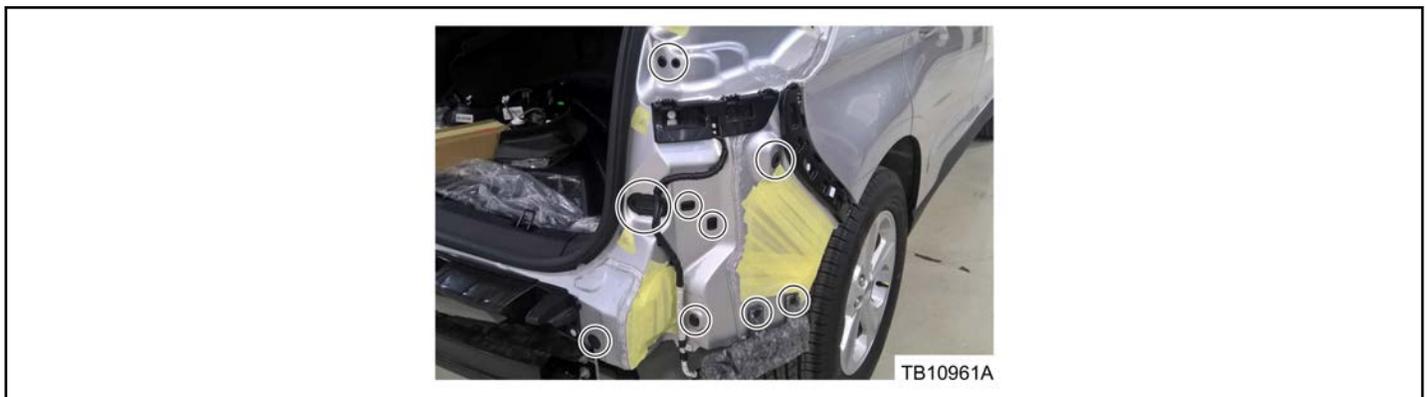
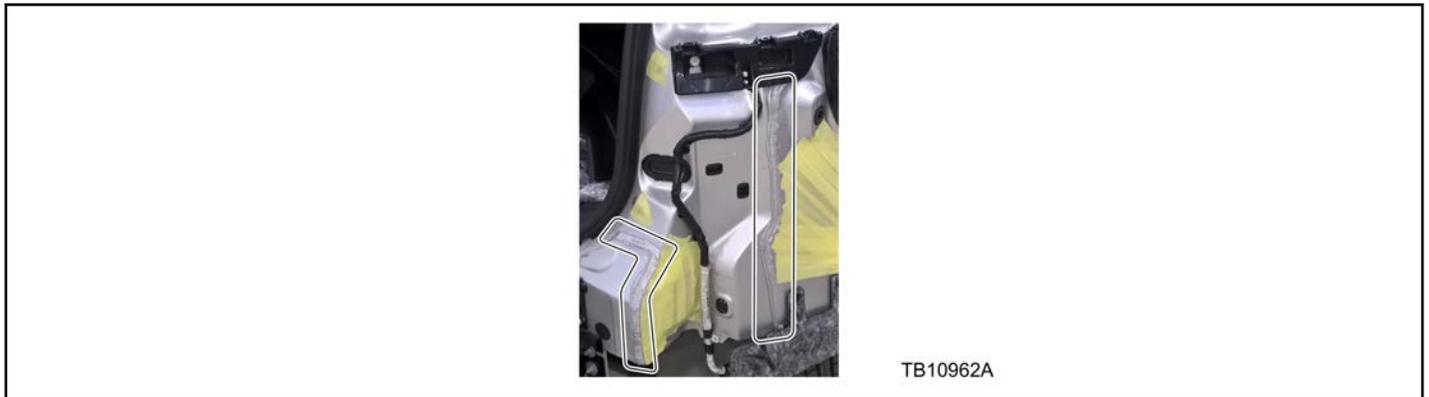
- c. Check for air leaks at all rear side body plugs, liftgate, grommets and pushpins. (Figures 15 - 16)

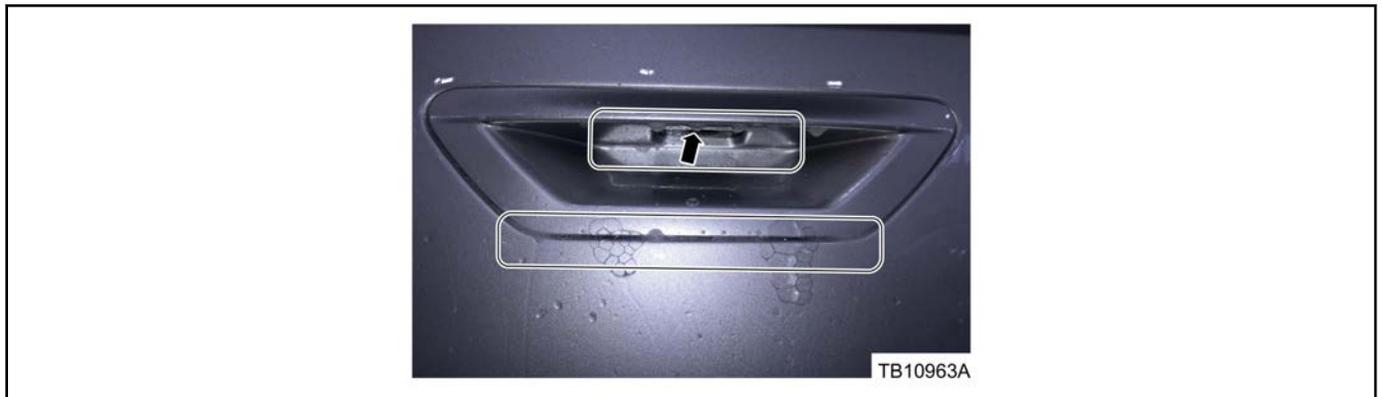
Figure 17 - Article 17-0035

- d. For the Edge, check for air leaks around the liftgate release switch housing and release switch located at the top of the housing. (Figure 17)

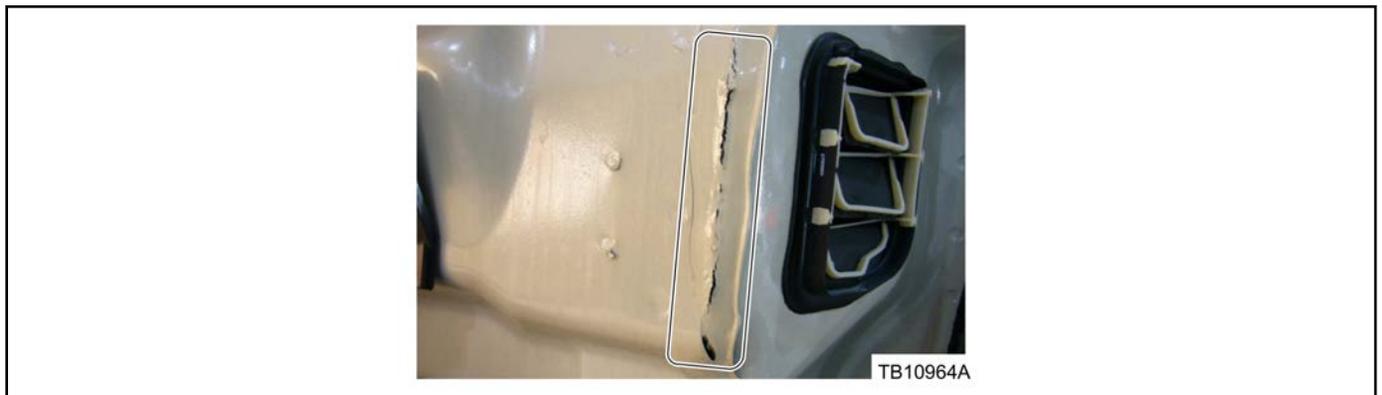
Figure 18 - Article 17-0035

- e. Closely check all body seams and body sealer applications located behind the rear bumper cover for air leaks, especially near the extractor vents. (Figure 18)

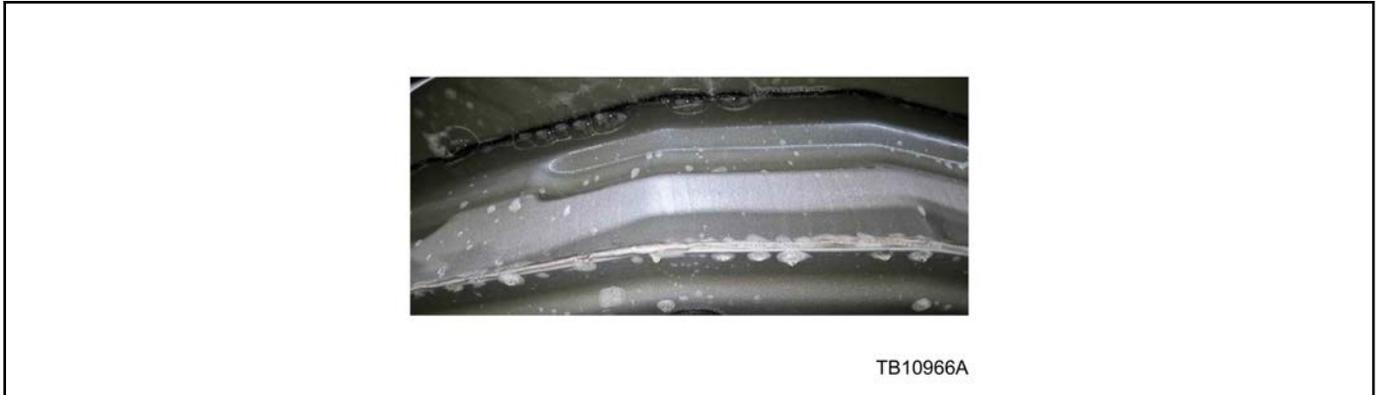
Figure 19 - Article 17-0035

- g. Raise the vehicle and inspect the entire upper and lower seams around the spare tire well for sealer gaps and air leaks. (Figure 19)

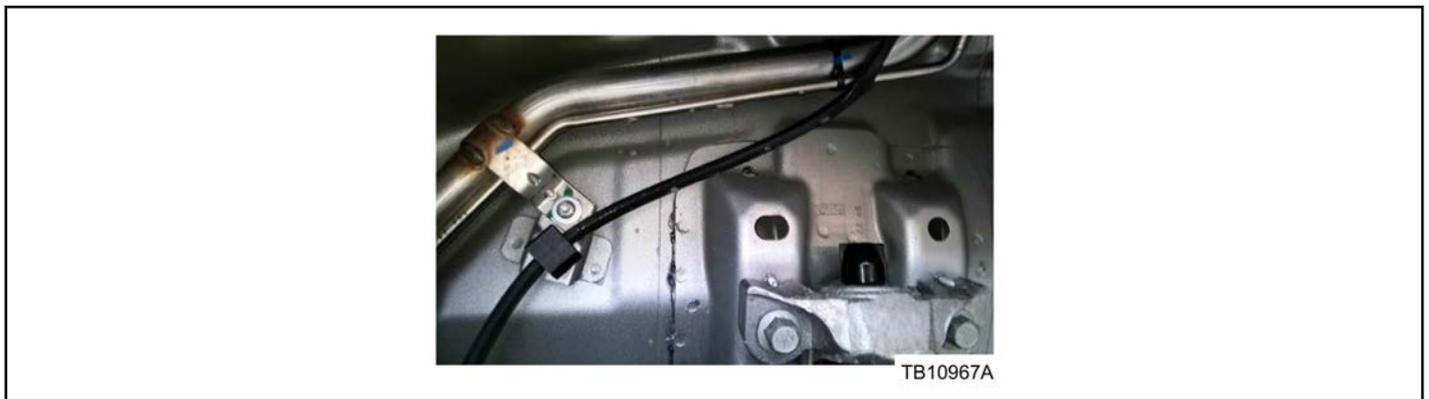
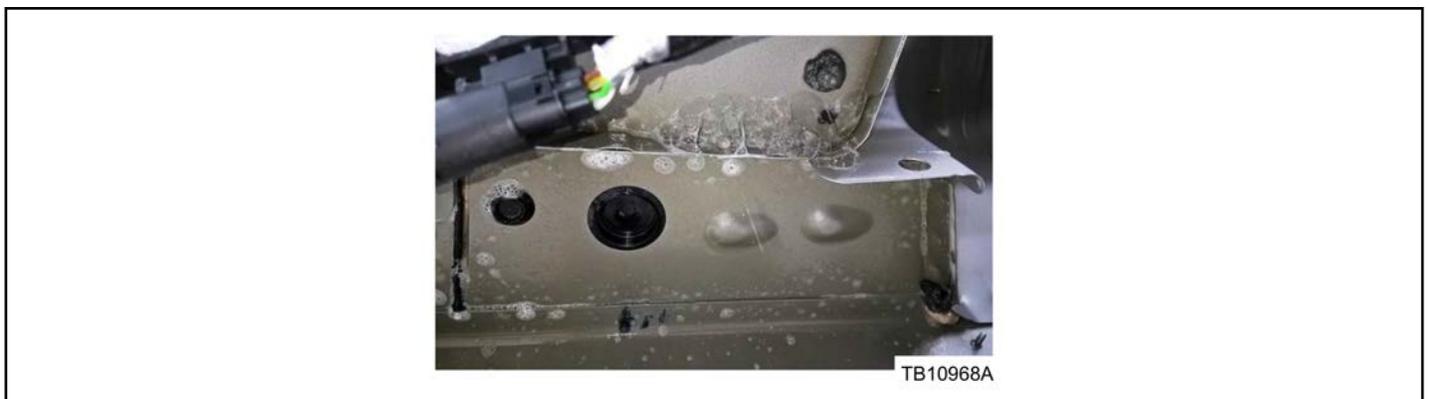
- h. Check the left and right boxed sections located at the rear underside of the vehicle for leaks at the seams and at any body plugs or grommets.
- i. Thoroughly check the rest of the rear underside of the vehicle for air leaks. (Figures 20 - 21)
