TECHNICAL BULLETIN
Q442 UPS9114-1bNAS1
08 DEC 2014

SECTION: 310-02

Update Prior to Sale: Accelerator Pedal Defective Switch

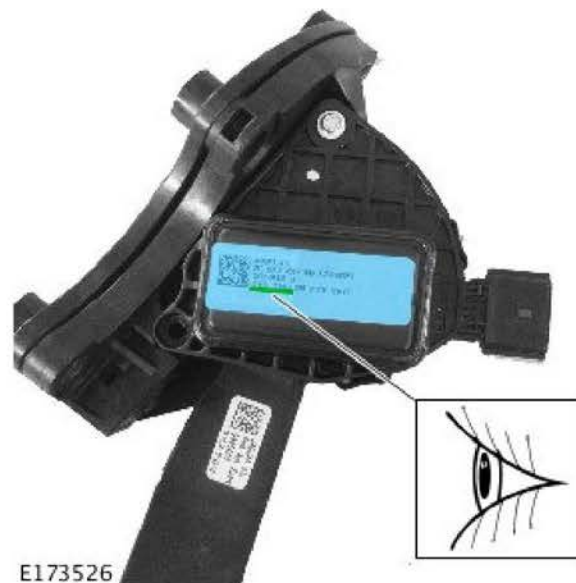
1. Check the accelerator pedal serial number.

- If the accelerator pedal serial number is NOT listed in SSM72100, release the vehicle for onward distribution or sale. No further action required.
- If the accelerator pedal serial number is listed in SSM72100, HOLD the vehicle pending detailed repair and parts ordering information.
