TECHNICAL BULLETIN  
Q500NAS1  
13 AUG 2015

**SECTION: 307-00**

Service Action: 9 Speed Automatic Transmission Calibration

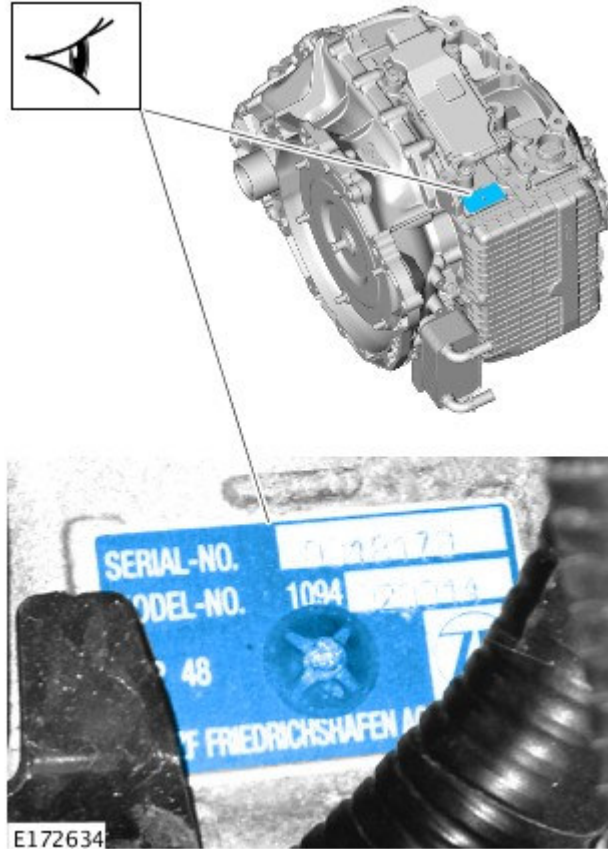
**NOTE: during the software update, SDD will prompt you for the transmission serial number. This can be found by looking between the engine and the air filter housing (a torch is required for this operation).**

Note the transmission serial number on the job card before continuing.
