January 5, 2017

05434 Version 1

Rattle from the Rear Tray While Playing Heavy Bass

Year	Model	Trim	VIN Range
2013–17	Accord	ALL 4-door	ALL

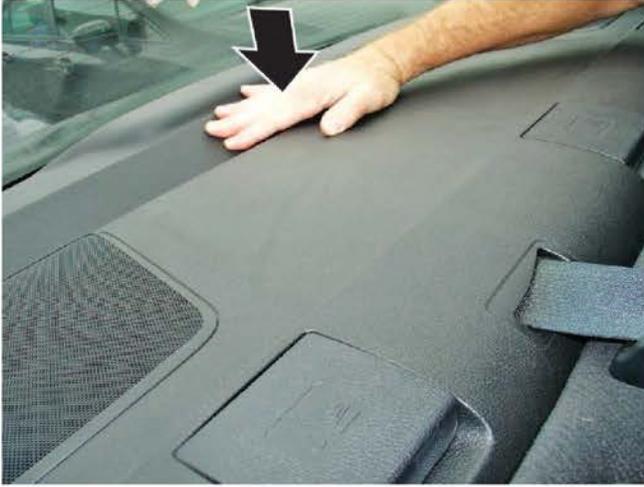
1. While playing the audio unit with heavy bass, press down on the area shown.
 - If the rattle goes away, go to REPAIR PROCEDURE.
 - If the rattle is still present, this bulletin does not apply. Continue with normal troubleshooting.

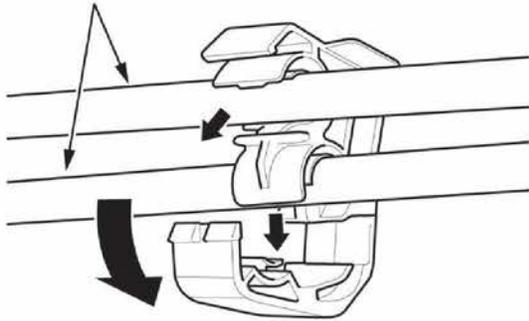
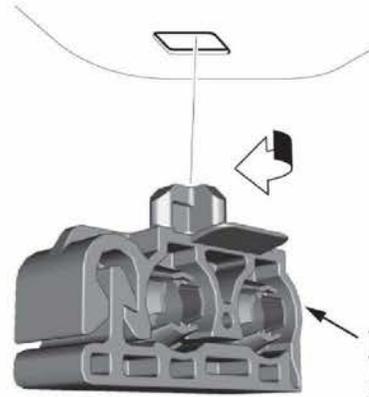
TRUNK LID TORSION BARS

**TRUNK LID
TORSION BAR CLIP
Replace.**

5. Remove the torsion bar clip and install the new torsion bar clip.

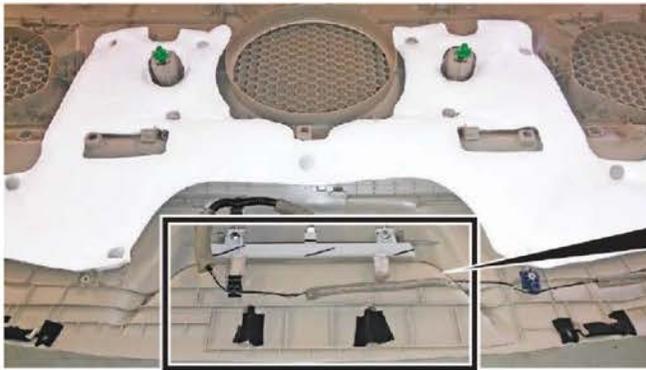
UNDERSIDE OF REAR SHELF:

25 mm X 45 mm WOOL FELT

6. Apply two pieces of 25 mm X 45 mm wool felt over the rear shelf area in the locations shown.

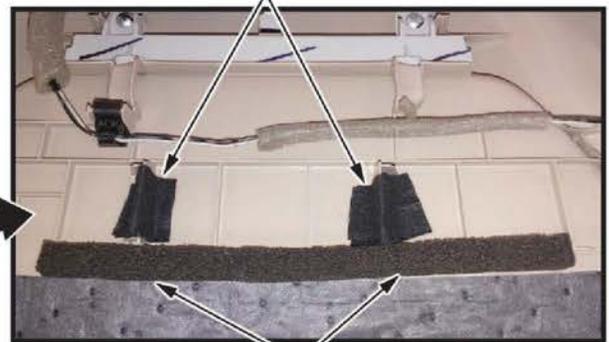
10 mm X 210 mm EPT SEALER

7. Apply a piece of 10 mm X 210 mm EPT sealer along the area shown.
8. Reinstall the rear shelf, and the applicable trim.
