Service Bulletin

16-095

High Pitched Buzzing/Alternator Feedback from the Speakers

Year	Model	Trim	VIN Range
2017	Ridgeline	RTL Black Edition, RTL Elite	ALL

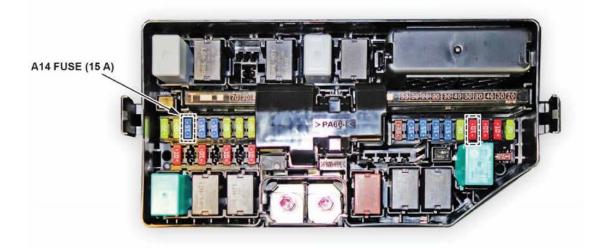
- 1. With the engine running and the rear blower off, turn the audio unit on. Then remove the A14 (15 A) fuse from the under-hood fuse relay box.
 - If the buzzing is gone or is reduced, go to REPAIR PROCEDURE.
 - If the buzzing is still present, this bulletin does not apply. Continue with normal troubleshooting.
