March 4, 2017

05860 Version 1

## 2013–17 Accord: Judder from the Torque Converter Lock-Up Clutch After Software Update

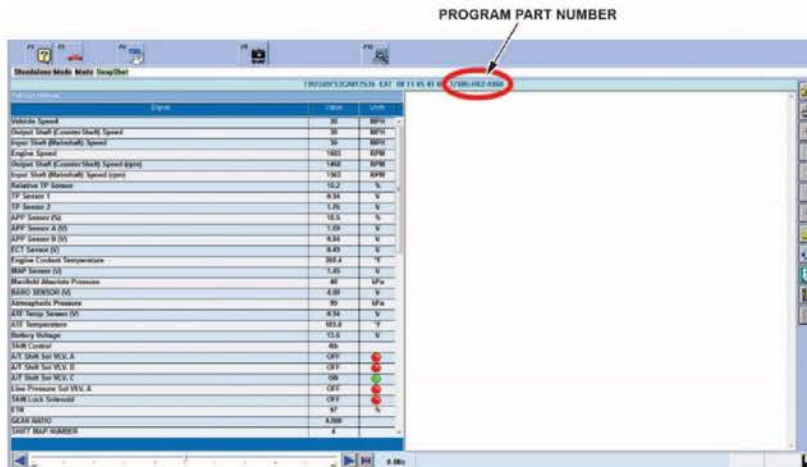
1. Connect the i-HDS, and go to the A/T Data List. Check to see if the software has been updated by comparing the program P/N against the table below.

- If the program P/N is listed below (or later), the vehicle has been updated. Go to step 2.

- If the program P/N is not listed, the vehicle has not been updated. Go to service bulletin 17-017 2013–17 Accord: Judder from the Torque Converter Lock-Up Clutch After Software Update.
2. Take an automatic transmission snapshot and forward it to Tech Line using the RO number. For more information about capturing and interpreting the data, refer to the job aid *Torque Converter Clutch Shudder and Vibration* and the *Tech2Tech®* video “Interpreting Torque Converter Judder Snapshot Data”.
    - If the snapshot indicates there is a judder, go to REPAIR PROCEDURE.
    - If the snapshot does not indicate a judder, this bulletin does not apply. Continue with normal troubleshooting. NOTE: **You do not need to contact Tech Line after sending the snapshot.** However, if you do not send a snapshot, your claim may be subject to debit.
