06125 Version 1

Flapping or Fluttering from the Left Rear of the Vehicle

AFFECTED VEHICLES

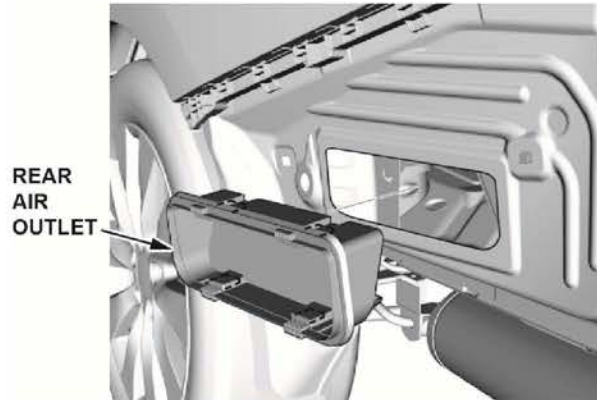
The noise is coming from the rear air outlet that is behind the rear bumper on the left side of the vehicle.

1. Remove the rear bumper. Refer to the service information.
2. Replace the left rear air outlet.
