April 13, 2017

06144 Version 1

## 2017 Ridgeline: Judder from the Torque Converter Lock-Up Clutch After Software Update

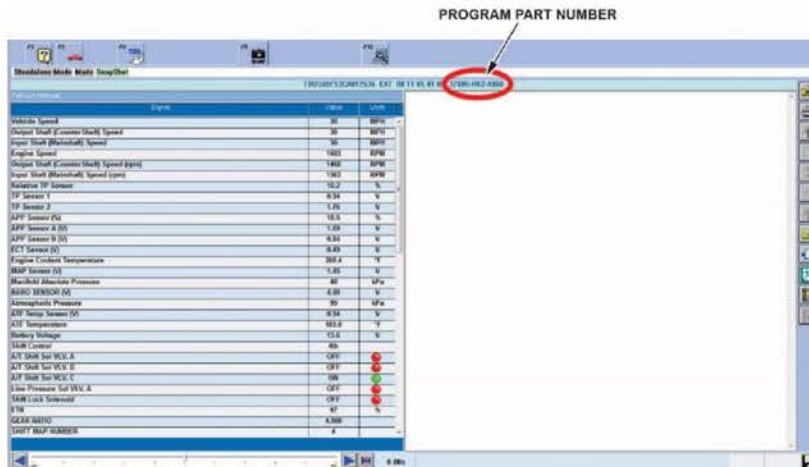
1. Connect the i-HDS, and go to the A/T Data List. Check to see if the software has been updated by comparing the program P/N against the table below.

- If the program P/N is listed below (or later), the vehicle has been updated. Go to step 2.

- If the program P/N is not listed, the vehicle has not been updated. Go to service bulletin 17-025 *2017 Ridgeline: Judder from the Torque Converter Lock-Up Clutch After Software Update*.
2. Take an automatic transmission snapshot and forward it to Tech Line using the RO number. For more information about capturing and interpreting the data, refer to the job aid *Torque Converter Clutch Shudder and Vibration* and the *Tech2Tech®* video "Interpreting Torque Converter Judder Snapshot Data".
    - If the snapshot indicates there is a judder, go to REPAIR PROCEDURE.
    - If the snapshot does not indicate a judder, this bulletin does not apply. Continue with normal troubleshooting. **NOTE: You do not need to contact Tech Line after sending the snapshot.** However, if you do not send a snapshot, your claim may be subject to debit.
