Bulletin No.: 16-NA-229

Subject: Information on Perceived Lumbar Back Massage Inoperative or Poor Performance

Ī	Brand:	Model:	Model Year:		VIN:		Engine:	Transmission:
	Diallu.	woder.	from	to	from	to		
	Buick	LaCrosse	2017	2017			All	All

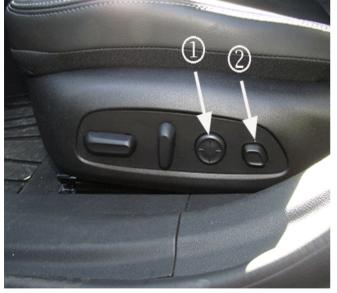
Involved Region or Country	NORTH AMERICA, CHINA			
Additional Options (RPO)	Equipped with CONTROL-SEAT, MASSAGE, DRIVER and PASSENGER (RPOs AF6 and AKE)			
Condition	Some customers may comment that the lumbar back massage is inoperative or exhibiting poor performance.			
Cause	The back massage intensity works in conjunction with the lumbar adjustment of the seat.  The cause of the condition may be that the lumbar adjustment of the seat may be in a decreased setting, which gives the perception that the massager is not functioning or is operating ineffectively.

**Note:** The location of the driver side seat lumbar adjustment control (1) and the message button (2) are shown in the graphic above.

Please communicate to the customer that the seat system is working as designed, however they can improve the intensity of the back massage by increasing the lumbar adjustment**prior** to activating the massage. The customer can also find further information in the Seats and Restraints section of their Owner Manual under *Lumbar Adjustment* and *Massage*.
