Service Bulletin

Bulletin No.: 16-NA-118

Subject: Engine Wiring Harness Chafing, No Start or Malfunction Indicator Lamp (MIL) ON

Brand:	Model:	Model Year:		VIN:		Engine:	Transmission:
Біапи.	wiodei.	from	to	from	to		
Chevrolet	Sonic	2013	2016			LUW, LWE	All

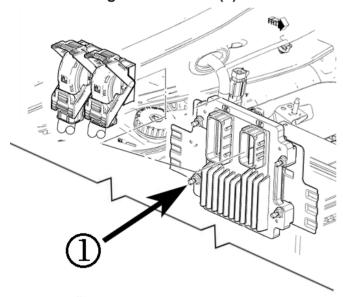
4487333

Condition	Some customers may comment on various conditions such as; no start, Malfunction Indicator Lamp (MIL) ON, and possible loss of steering assist.	
Cause	Technicians may find the engine harness routed too close to the ECM lower mounting bracket stud. The stud can pierce the harness, and chafe and short wires inside the harness.	
Additional Options	Equipped with 1.8L L4 LUW or 1.8L L4 LWE engine

ECM Mounting Bracket Stud (1) Contact Area

Inspect the harness for signs of contact or damage. Reroute or repair as necessary.
