Service Bulletin

Bulletin No.: 16-NA-028

Subject: Air Conditioning Not Getting Cold Enough or Blows Warm Air

Brand:	Model:	Model Year:		Breakpoint		Engine:	Transmission:
		from	to	from	to		
Chevrolet	Sonic	2015	2016	SOP 2015	April 1, 2016	All	All
Chevrolet	Trax	2015	2016	SOP 2015	April 1, 2016	All	All

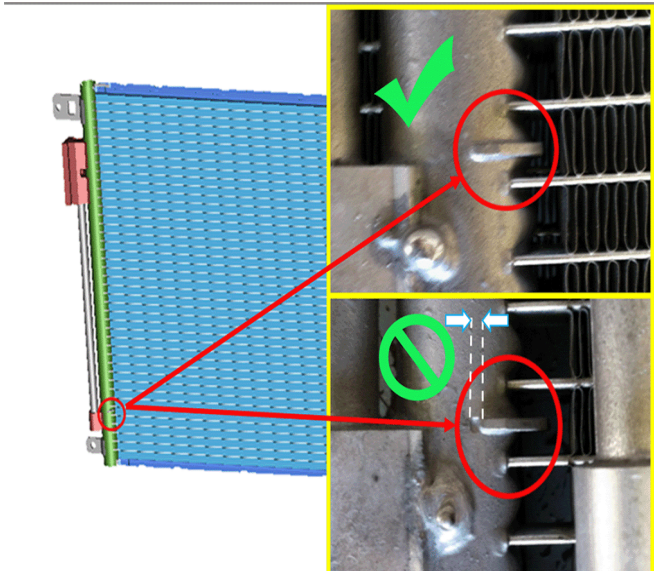
<p style="text-align: right;">4376188</p> <p>The A/C condenser supplier has found that the cause may be a block off plate that was mis-positioned during their manufacturing process. The plate may not have been fully seated prior to welding, so it may not be directing the flow of refrigerant through an area of the condenser as design intended.</p>

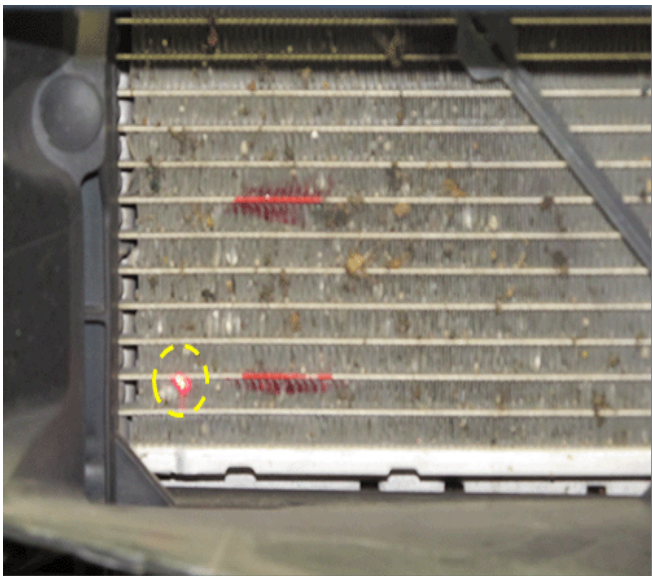
4376195

- 4.1. Take a reading at lower tube #2, designated by the lower red line in the graphic above. To obtain a proper reading, the gun beam should be positioned directly on tube #2, about 25 mm (1.0 in) to the right of the manifold.

4. Accessing the left side lower grille area, use an Infrared thermal gun to take a reading at 2 locations noted in the steps below, and record temperatures and note temperature difference.

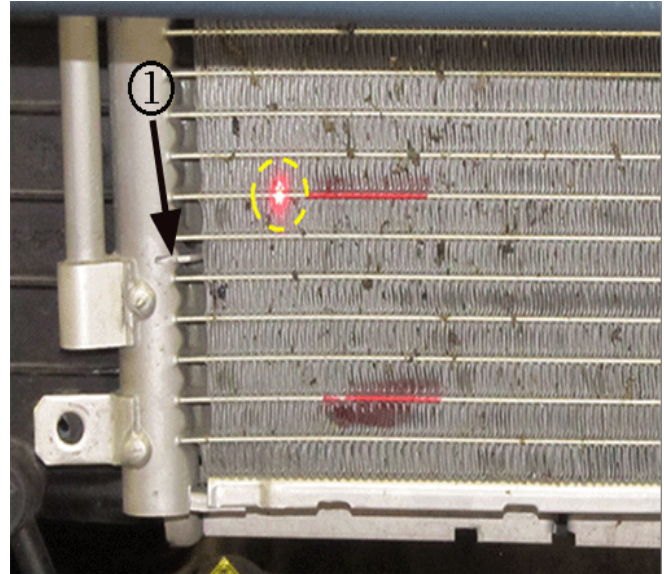
4376196

Note: The condenser air baffle has been removed in the graphic above for illustration purposes only. The intent was to show that the #7 tube is 2 tubes above the blocking plate (1).

- 4.2. Next, move the laser dot to the #7 tube (designated by the upper red line). Take a reading ensuring the beam is positioned directly on the tube, approximately the same position from the manifold.
- If the difference in the reading is at least 10 degrees F or **more**, the condenser is functioning properly and further diagnostics will need to be completed to verify the cause of the condition.
 - If the difference in the reading is approximately the same, or within 10 degrees **or less**, the vehicle has a misbuilt condenser. Prior to replacement, confirm that during temperature readings taken, the compressor was running for at least 10 seconds and was still running during measurements. If so, replace the A/C condenser. Refer to the appropriate *Air Conditioning Condenser Replacement* in SI.
