Service Bulletin

Bulletin No.: 16-NA-004

Subject:

Intermittent Multiple IPC Warning Lamps Illuminated, Loss of Power Steering Assist, No Crank/No Start, Service Power Steering Message on DIC, Malfunction Indicator Lamp Illuminated, Multiple HSLAN U-Codes Set

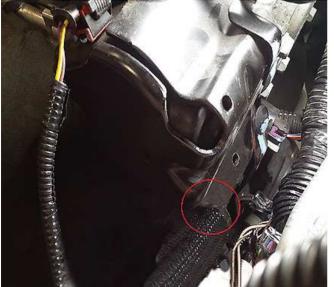
/363210

Involved Region or Country	North America and N.A. Export Regions		
Condition	Some customers may comment on the following conditions: Intermittent multiple IPC warning lamps illuminated. Loss of power steering assist. No crank/no start. Service Power Steering message. Malfunction Indicator Lamp illuminated. Multiple HSLAN U-Codes set.		
Cause	This may be caused by the engine wiring harness chaffing on the edge of the fuel pump cover.

- 1. Inspect the engine wiring harness conduit and wires for chaffing.
- 2. Repair the wires per the *Wiring Repairs* procedure in SI.

- 3. Wrap the engine wiring harness with Polyester Electrical/Anti-Abrasive Tape (PET) or equivalent anti-abrasion tape.
- 4. Using a small metal file, remove any burrs and sharp edges along the fuel pump cover edge in the area illustrated above.
- 5. Position the engine wiring harness away from the edge of the fuel pump cover.
