Service Bulletin

Bulletin No.: 16-NA-042

Subject: Infotainment System Upgrade for Android Auto Feature

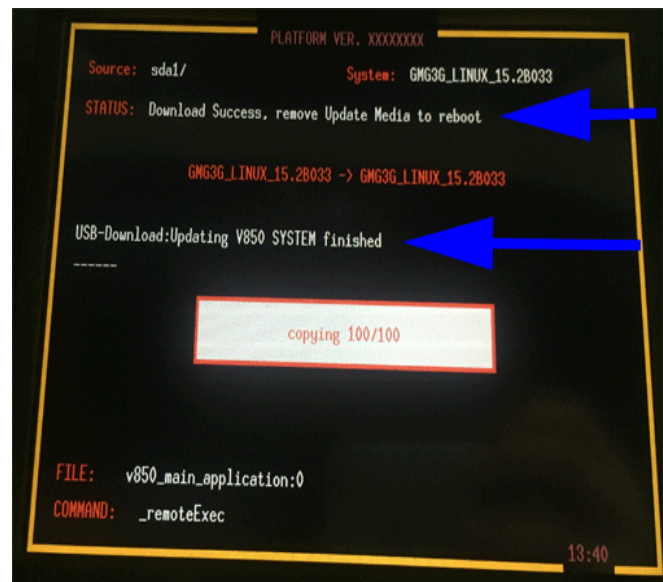
4448895

Important: Once the updating file hits 90% the screen may go blank. DO NOT REMOVE the USB at this time. The illustration above shows when the programming is complete. (See blue arrows above.)

7. Connect the USB drive to the USB port in the vehicle.
8. The infotainment system will recognize that update files are available. Follow the infotainment display on-screen instructions and select Update when prompted. Programming will take several minutes.

9. Upon completion of programming, remove the USB drive. Follow the infotainment display on-screen instructions.
10. Access the Service Programming System (SPS) and follow the on-screen instructions.
11. On the SPS Supported Controllers screen, select K74 Human Machine Interface Control Module – Programming and follow the on-screen instructions.

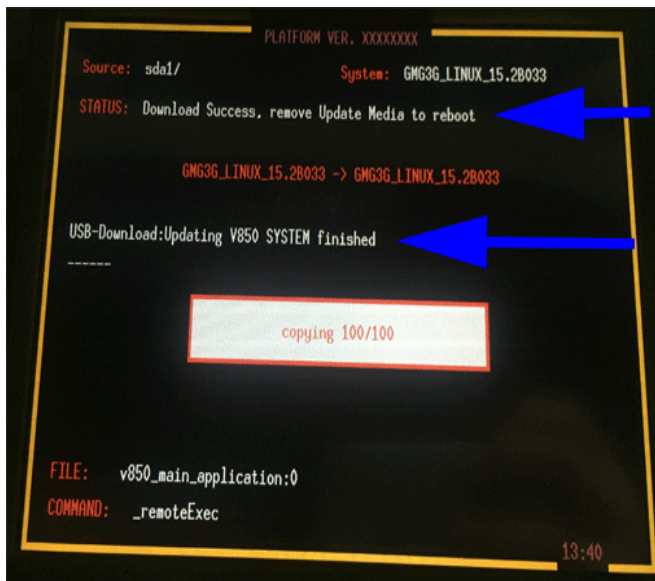
4448895

Important: Once the updating file hits 90% the screen may go blank, DO NOT REMOVE the USB at this time. The illustration above shows when the programming is complete. (See blue arrows above.)

7. Connect the USB drive to the USB port in the vehicle.
 8. The infotainment system will recognize that update files are available. Follow the infotainment display on-screen instructions and select Update when prompted. Programming will take several minutes.

9. Upon completion of programming, remove the USB drive. Follow the infotainment display on-screen instructions.
10. Access the Service Programming System (SPS) and follow the on-screen instructions.
11. On the SPS Supported Controllers screen, select K74 Human Machine Interface Control Module – Programming and follow the on-screen instructions.
