Service Bulletin

Bulletin No.: 16-NA-161

Subject: Intermittent No Crank, No Start, Remote Start Inoperative, Anti-Theft Light On, Malfunction Indicator Light (MIL) Illuminated

Brand:	Model:	Model Year:		VIN:		Engine:	Transmission:
		from	to	from	to		
Chevrolet	Impala	2015	2016			LFX

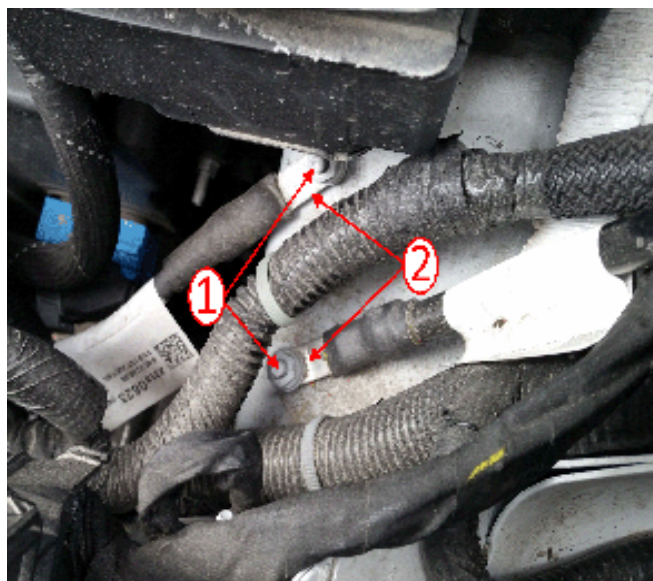
4514976

Involved Region or Country	North America, Israel, Korea, Saudi Arabia
Condition	<p>The customer may comment on one or more of the following conditions:</p> <ul style="list-style-type: none">• Vehicle won't start.• Vehicle will intermittently not crank over.• Push start does not function.• Remote start does not function.• Anti-Theft light is on.• Multifunction indicator lamp illuminated. <p>A Technician may find DTC P0513 set.</p>
Cause	<p>This condition may be caused by a loose or corroded ground terminal at the G103 ground location .</p>

Note: The stud and surrounding panel area **MUST BE** properly cleaned and prepped **PRIOR** to the installation of the ground wire terminal and conductive nut to maintain a secure, stable and corrosion-free electrical ground.

1. Remove the conductive nut that secures the G103 ground cable (2) to the frame.
2. Using GM approved residue-free solvent or equivalent, thoroughly clean the stud threads (1) to remove any adhesive and allow to dry.
3. Carefully remove ANY corrosion or contamination that may be present on the electrical ground wire terminal.
4. Using a small brush, apply dielectric lubricant to the threads of the conductive stud.
5. Ensure the terminals are indexed properly so that it is fully seated on the stud prior to tightening the G103 terminal.
6. **Tighten** the conductive nut to 9 Y (80 lb in).
