# Service Bulletin

Bulletin No.: 16-NA-169

**Subject: Unwanted Trunk Opening, Unable to Open Trunk, Back Up Camera and/or License Plate Lamps Inoperative**

Brand:	Model:	Model Year:		VIN:		Engine:	Transmission:
		from	to	from	to		
Cadillac	XTS	2013	2016			All	All

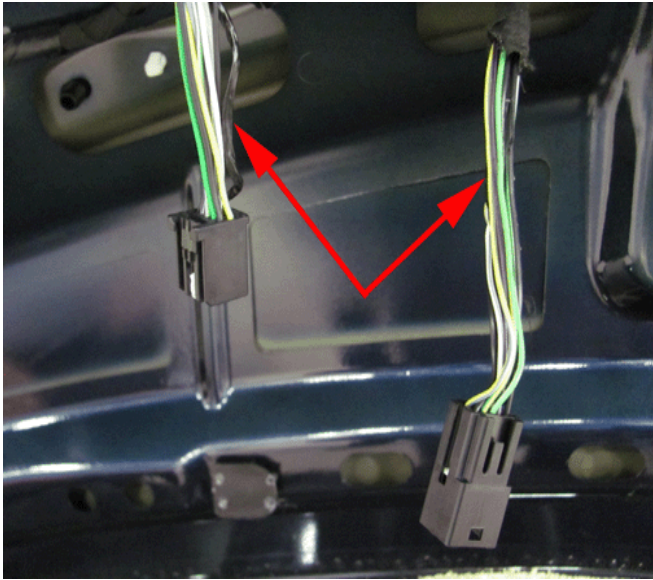
4519705

3. Disconnect the applique wiring harness connector.
4. Visually inspect the applique wiring harness and body harness connector for corrosion.
  - If corrosion is present, continue onto step 5.
  - If corrosion is not present, continue diagnosis referring to SI.
