Service Bulletin

Bulletin No.: 16-NA-170

Subject: Brake Pulsation and/or Vibration During Brake Apply

Brand:	Model:	Model Year:		VIN:		Engine:	Transmission:
		from	to	from	to		
Chevrolet	Corvette	2014	2016

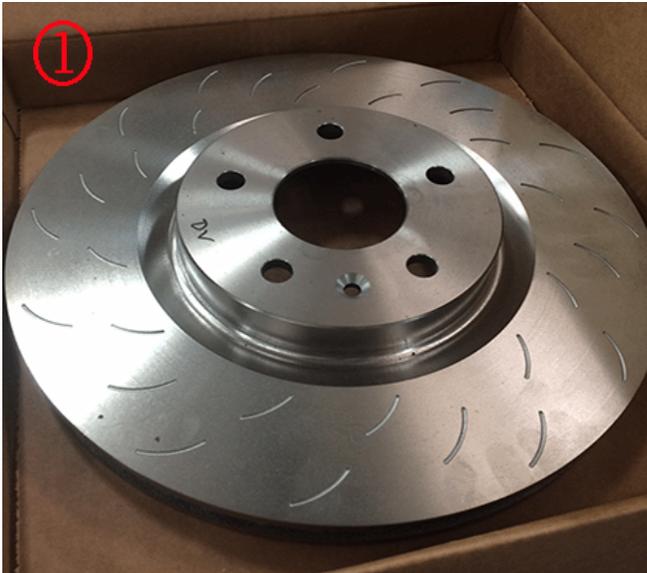
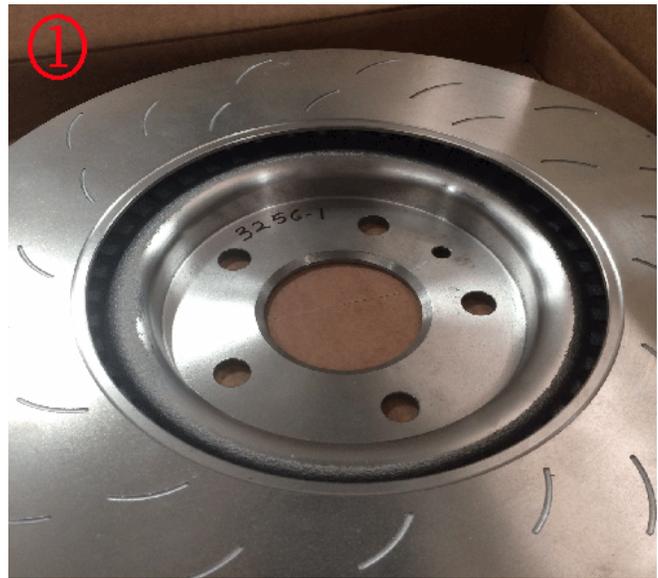
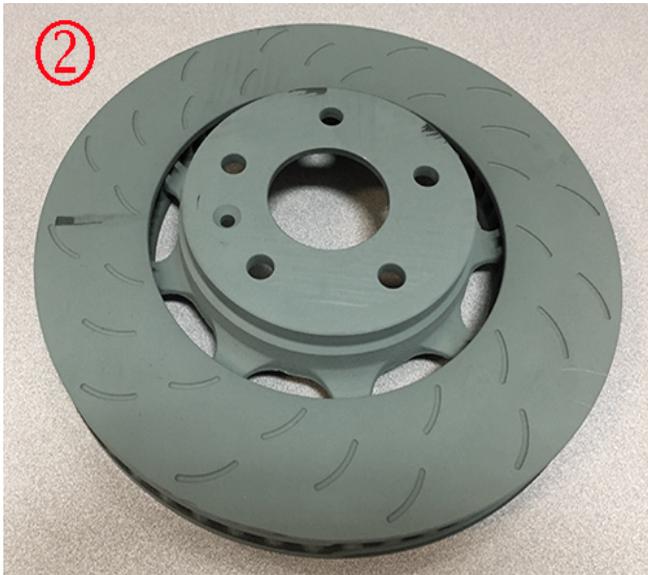
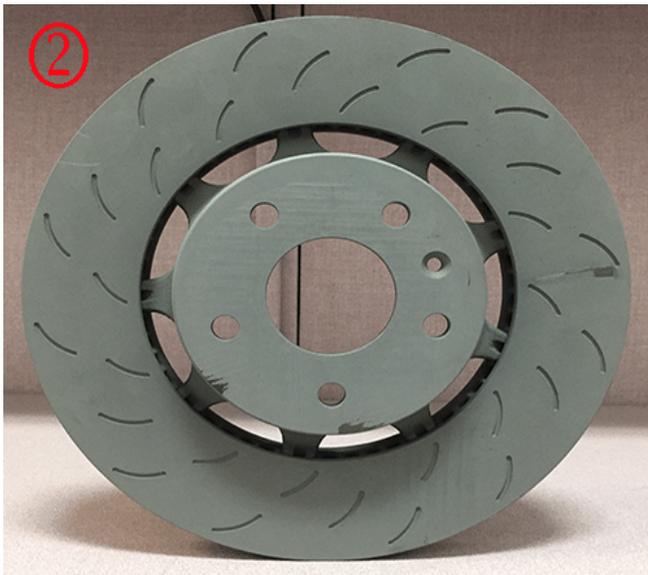
Check the lateral runout and replace the affected rotors with the new one piece design (1) **NOT** the old two piece design (2).

Important: The rotors **MUST** be replaced as a pair due to a design change.

Note: **DO NOT** replace all brake rotors unless you find the lateral runout out of spec for both the front and rear corners.
