NUMBER
072A (Rev 1, 1/10/2018)

MODEL
2017MY
Multiple Models

TECHNICAL SERVICE BULLETIN

SUBJECT: SERVICE ACTION: INHIBITOR SWITCH
REPLACEMENT (SA317A)

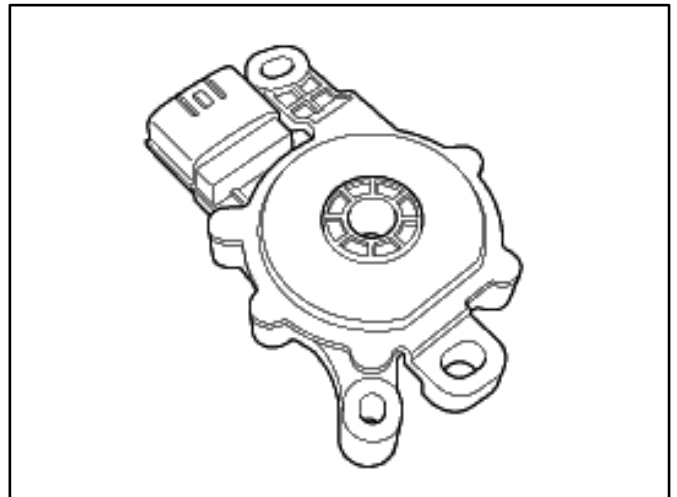
- Malfunction Indicator Lamp (MIL) ON with DTC P0705 - Transmission Range Sensor (TRS) Circuit Malfunction (active or history)
- CAN-related DTCs (For both Hybrids: CAN DTC C2243)
- Intermittent no crank/no start
- Erratic or harsh shifting
- EPB and Hold lights illuminated intermittently
- Slight engine stumble when placed into Park ('P') position after a long drive
- No "Key OFF" indicated after placing the selector lever into the 'P' position and depressing the Start/Stop button. Note: When this condition occurs, the 'P' position is not indicated on the instrument cluster.

1. Replace the inhibitor switch by referring to the “Automatic Transaxle System → Automatic Transaxle Control System → Inhibitor Switch → Repair procedures” chapter of the applicable Shop Manual on KGIS.

2. Clear any related DTCs if necessary.
3. Confirm proper operation of vehicle.
