GROUP	NUMBER	
CAMPAIGN	18-01-003	
DATE	MODEL(S)	
JANUARY, 2018	IONIQ ELECTRIC (AE EV)

CHARGING CONNECTOR LOCK/UNLOCK ACTUATOR REPLACEMENT (SERVICE CAMPAIGN T2T)

This bulletin provides the service procedure to replace the charging connector lock/unlock actuator.

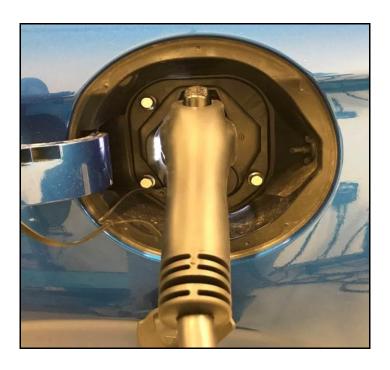
Description: Some Ioniq EV (AE EV) vehicles may experience the charging connector lock/unlock actuator malfunction, which may cause:

- The charging connector does not remain locked when the charger is inserted into the charging port.
- The charging connector cannot be removed from the vehicle charging port.
