<b>GROUP</b> <b>Electrical</b>	<b>MODEL</b> <b>2018MY</b> <b>Rio (SC)</b>
	<b>NUMBER</b> <b>PS529 (Rev 1, 01/16/2018)</b>	<b>DATE</b> <b>November 2017</b>

**SUBJECT:** TPMS LAMP ON AND/OR TRUNK OPEN LAMP ON AND/OR AUDIO SYSTEM INOPERATIVE DURING PDI

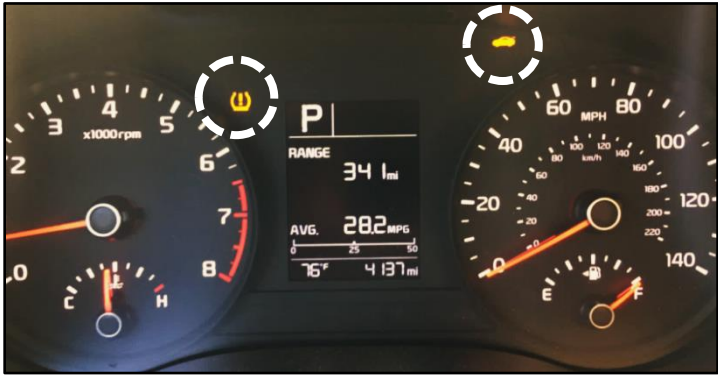
This Pitstop contains information regarding the the Audio System inoperative, and TPMS lamp ON, Trunk Open warning lamp ON (even while the trunk is closed), and Master Warning Mode lamp ON in the instrument cluster during PDI. This condition may be caused by the Transportation Fuse being in the OFF position.

**Type A cluster.**

Verify that the transportation fuse is ON (this can be done by ensuring the yellow transportation fuse tab holder is fully pressed into the In-Panel Junction Box, located in the lower driver’s side crash pad) and that neither the AUDIO (A) nor ROOM (B) fuses are blown.

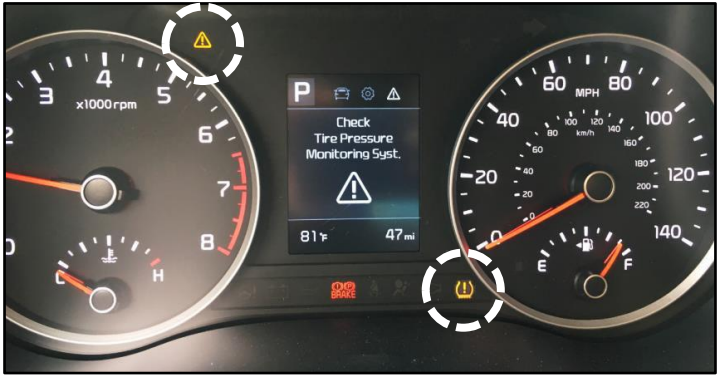
**Type B cluster.**
