MODEL  
2017MY  
Forte (YDm)

NUMBER  
157

**SUBJECT:** SERVICE ACTION: REAR COMBINATION  
LAMP WATER INTRUSION (SA256)

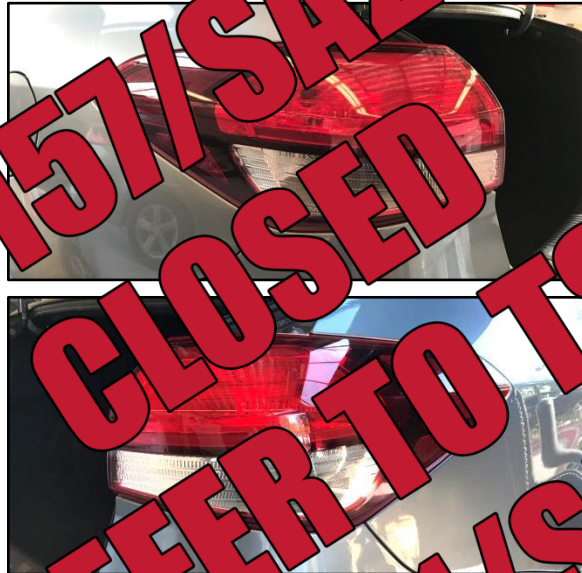
This bulletin provides the procedure to replace the outer rear combination lamp pads on some 2017MY Forte (YDm) vehicles, produced from May 24, 2016 to October 13, 2016, which may exhibit evidence of water intrusion in the outer rear combination lamps. Follow the procedure outlined in this bulletin to replace both left and right outer rear combination lamp pads. Before conducting the procedure, verify that the vehicle is included on the list of affected VINs.
