MODEL  
2018MY  
Stinger (CK)

NUMBER  
178 (Rev 1, 1/30/2018)

SUBJECT: SERVICE ACTION: RATTLE NOISE  
FROM TAILGATE (SA322)

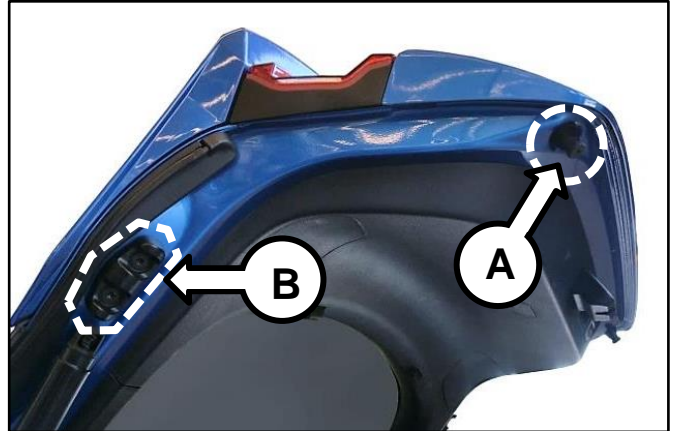
1. Open the tailgate. Locate both tailgate overslam bumpers (A) and guide bumpers (B) on both sides (left side shown in photo).
