MODEL
2018MY
Optima (JFa)

NUMBER
182 (Rev 1, 1/11/2018)

TECHNICAL SERVICE BULLETIN

SUBJECT: SERVICE ACTION: FLOOR CONSOLE INNER PANEL
INSPECTION & CORRECTION/REPLACEMENT (SA328)

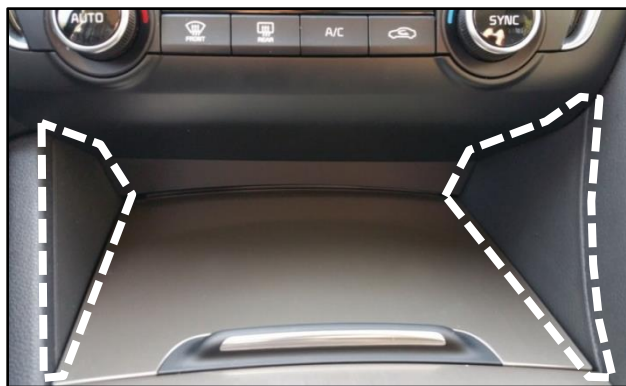
This bulletin provides the procedure to inspect and correct or replace the floor console inner side panels on some 2018MY Optima (JFa) vehicles, produced from August 1, 2017 through October 27, 2017, which may exhibit a peeling condition of the panel surface. If there is no sign of peeling at the inner side panels of the floor console, perform the solution application procedure on page 2 of this bulletin. If there is sign of peeling, replace the inner side panels by following the replacement procedure on page 3 of this bulletin. Before conducting the procedure, verify that the vehicle is included in the list of affected VINs.

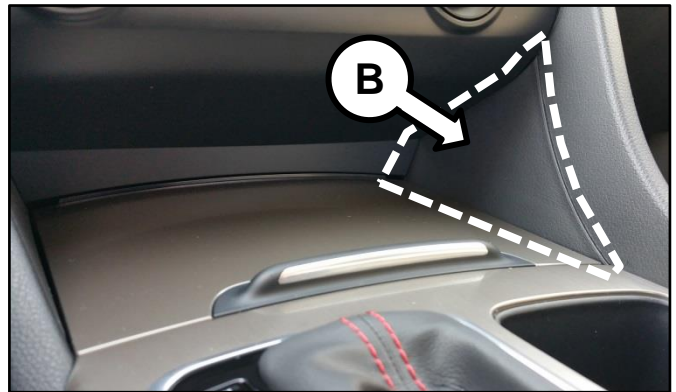
1. Inspect both left and right inner side panels (A) & (B) of the floor console for any sign of surface peeling.
 - If neither left nor right panels are peeling, proceed to Solution Application Procedure below to apply a corrective spray solution.
 - If one or both panels is/are peeling, proceed to the Replacement Procedure on page 3 of this bulletin.
