# SERVICE BULLETIN

Classification: EC13-007b	Reference: NTB13-054b	Date: January 11, 2018
------------------------------	--------------------------	---------------------------

## ALTIMA AND ROGUE; ENGINE TURNS OFF OR HESITATES WHEN ACCELERATING FROM A STOP DURING HOT AMBIENT TEMPERATURES (+100° F)

**APPLIED VEHICLES:** 2013-2017 Altima Sedan (L33)  
2014-2017 Rogue (T32)

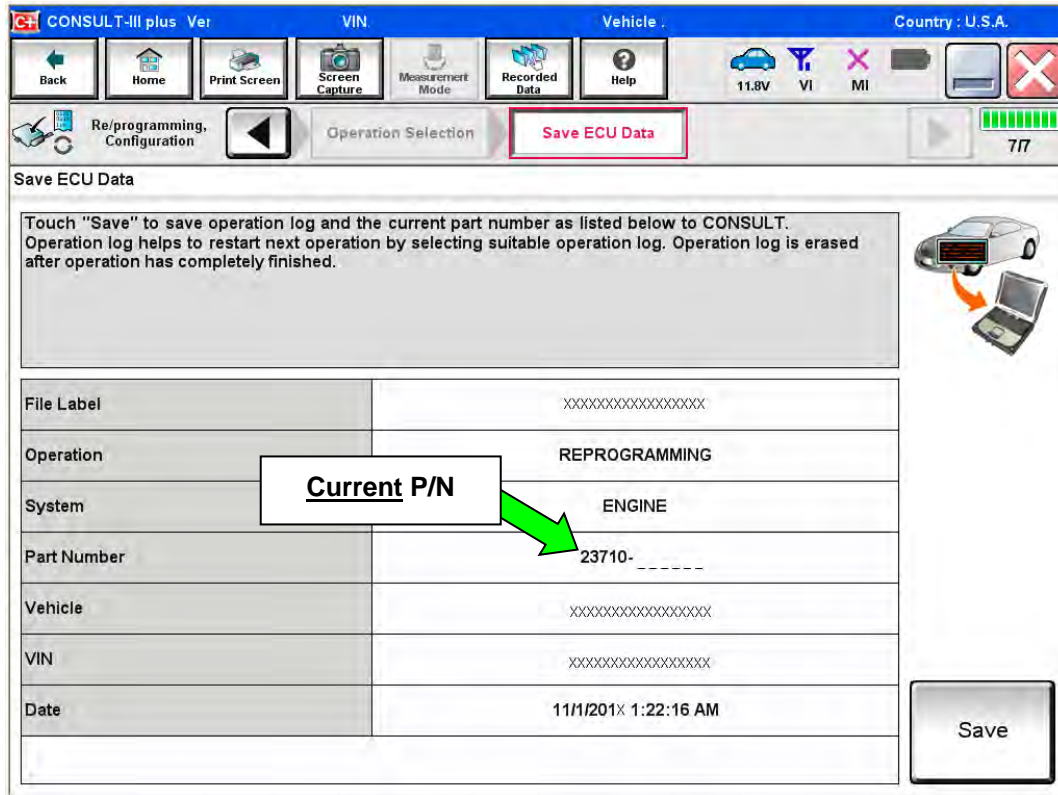
Figure 2

6. When you get to the screen shown in Figure 2, confirm this bulletin applies as follows:

A. Find the ECM **Part Number** and write it on the repair order.

**NOTE:** This is the current ECM Part Number (P/N).

B. Compare the P/N you wrote down to the numbers in the **Current ECM Part Number** column in **Table A** on pages 5 and 6.

- If there is a match, this bulletin applies. Continue with the reprogramming procedure.
- If there is not a match, this bulletin does not apply. Return to ASIST for further diagnostic and repair information.

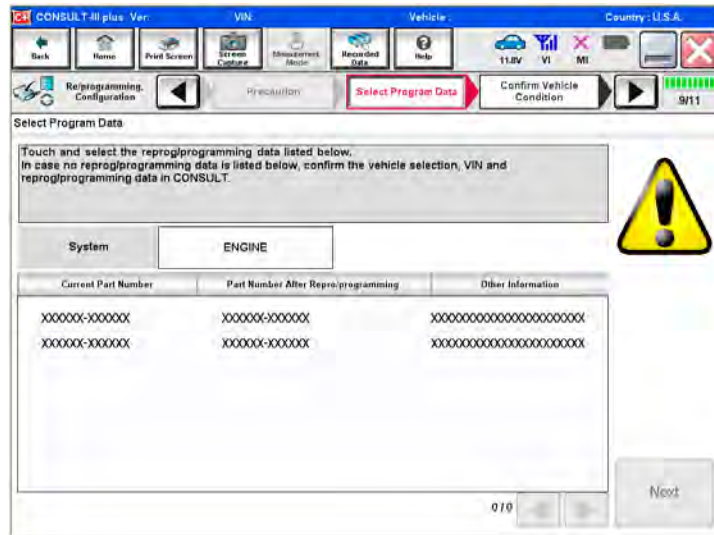
- In some cases, more than one new P/N for reprogramming is available.
  - In this case, the screen in Figure 3 displays.
  - Select and use the reprogramming option that **does not** have the message “Caution! Use ONLY with NTBXX-XXX”.
- If you get this screen and it is blank (no reprogramming listed), it means there is no reprogramming available for this vehicle.

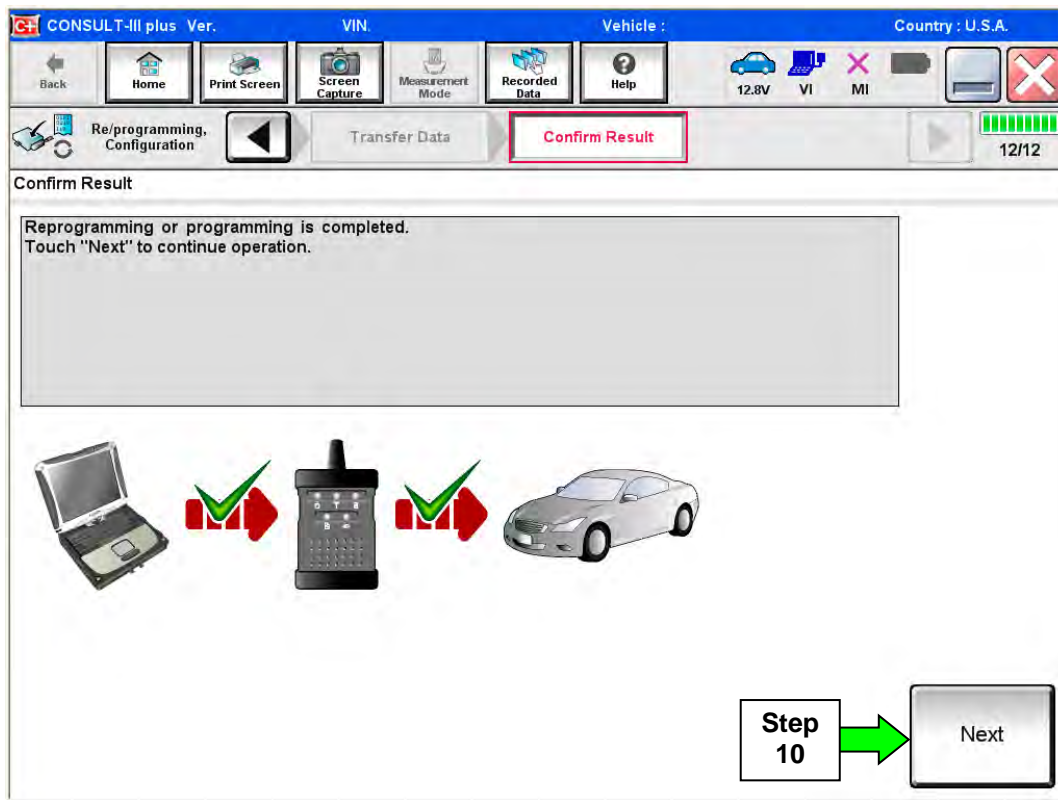
8. When the screen in Figure 5 displays, reprogramming is complete.

**NOTE:** If the screen in Figure 5 does not display (which indicates reprogramming did not complete), refer to the information on the next page.

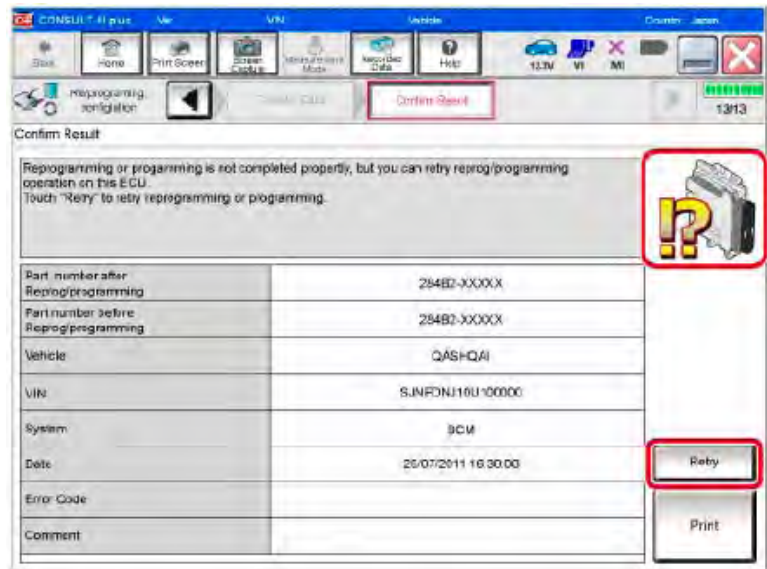
Figure 6

**If reprogramming does not complete and the “!” icon displays as shown in Figure 6:**

- Check battery voltage (12.0 - 15.5 V).
- Ignition is ON, engine OFF.
- External Bluetooth® devices are OFF.
- All electrical loads are OFF.
- **Select retry and follow the on screen instructions.**
- “Retry” may not go through on first attempt and can be selected more than once.

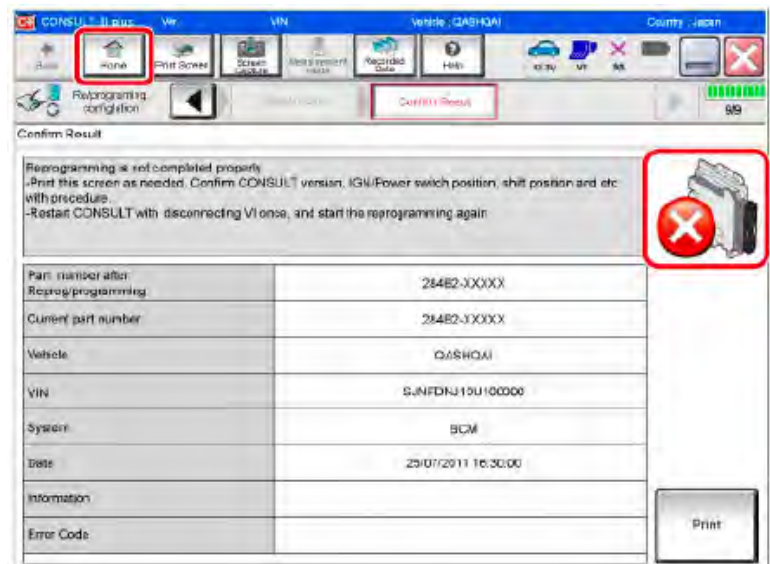
Figure 7

**If reprogramming does not complete and the “X” icon displays as shown in Figure 7:**

- Check battery voltage (12.0 - 15.5 V).
- CONSULT A/C adapter is plugged in.
- Ignition is ON, engine OFF.
- Transmission is in Park.
- All C-III plus / VI cables are securely connected.
- All C-III plus updates are installed.
- **Select Home, and restart the reprogram procedure from the beginning.**

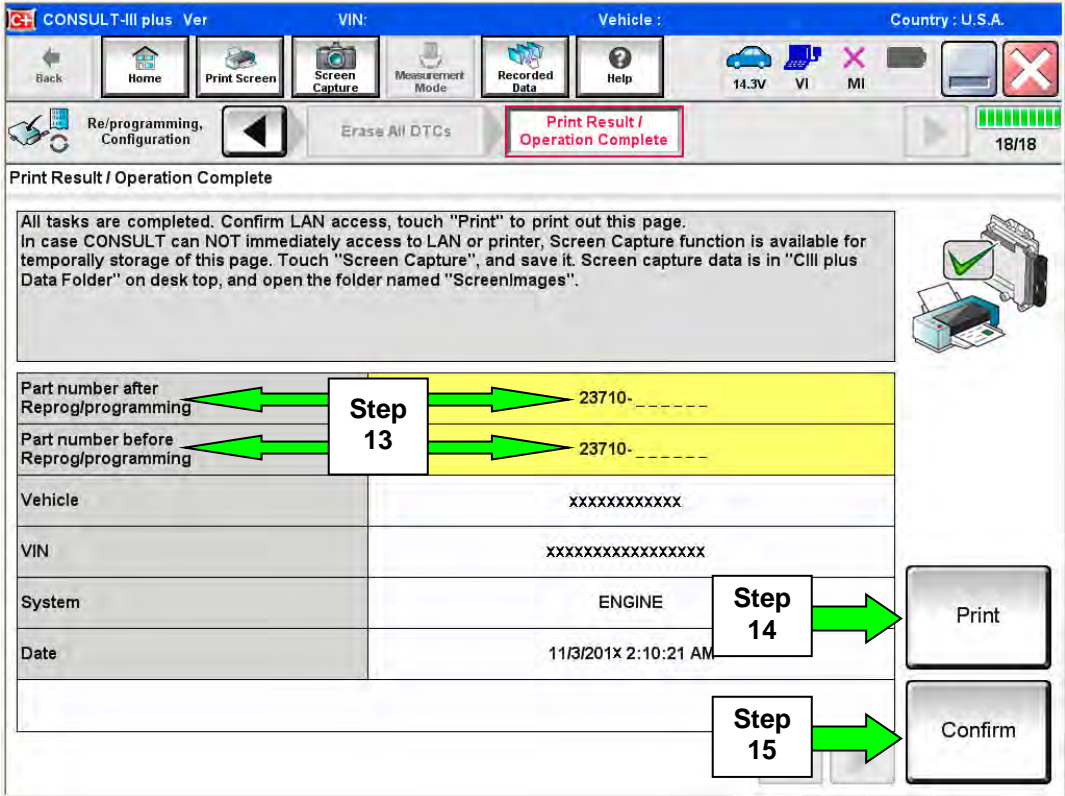
- 12. When the entire reprogramming process is complete, the screen in Figure 8 will display.
- 13. Verify the before and after part numbers are different.
- 14. Print a copy of this screen (Figure 8) and attach it to the repair order for warranty documentation.
- 15. Select **Confirm**.
