## Service Bulletin

**01-18**

ESA - Cluster Not Detected

Peterbilt has determined that in certain Model 579/567 vehicles manufactured between 12/11/2017 and 01/02/2018 and received an ECU update between 12/08/2017 and 01/17/2018 may display "Cluster Not Detected" error message when ESA is connected to the CECU3.

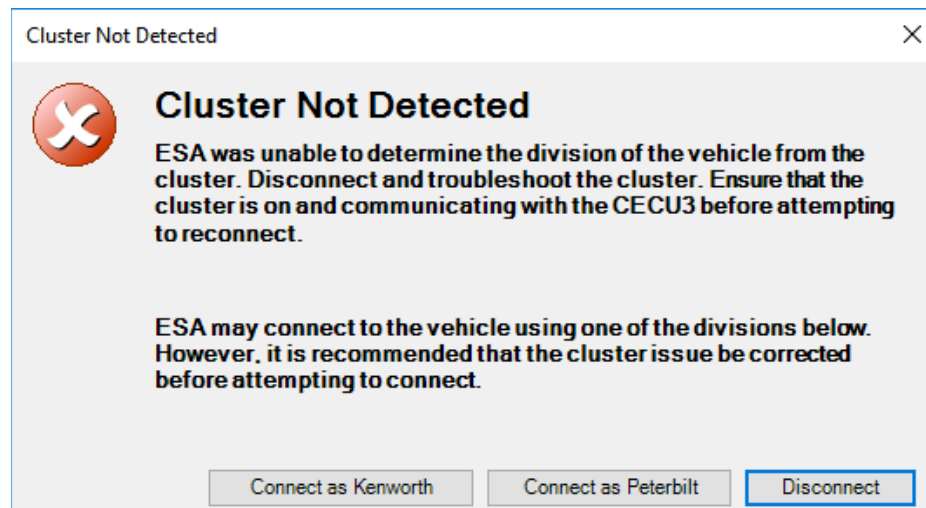
1. Ensure that ESA has the latest available update. See the documents located on the ESA Administration page (you can find these in the ESA Administration Quick Link in the Eportal Service tab) to update the ESA software.
2. Connect ESA to the CECU. The following message may display if the cluster is not detected. Select the appropriate division.

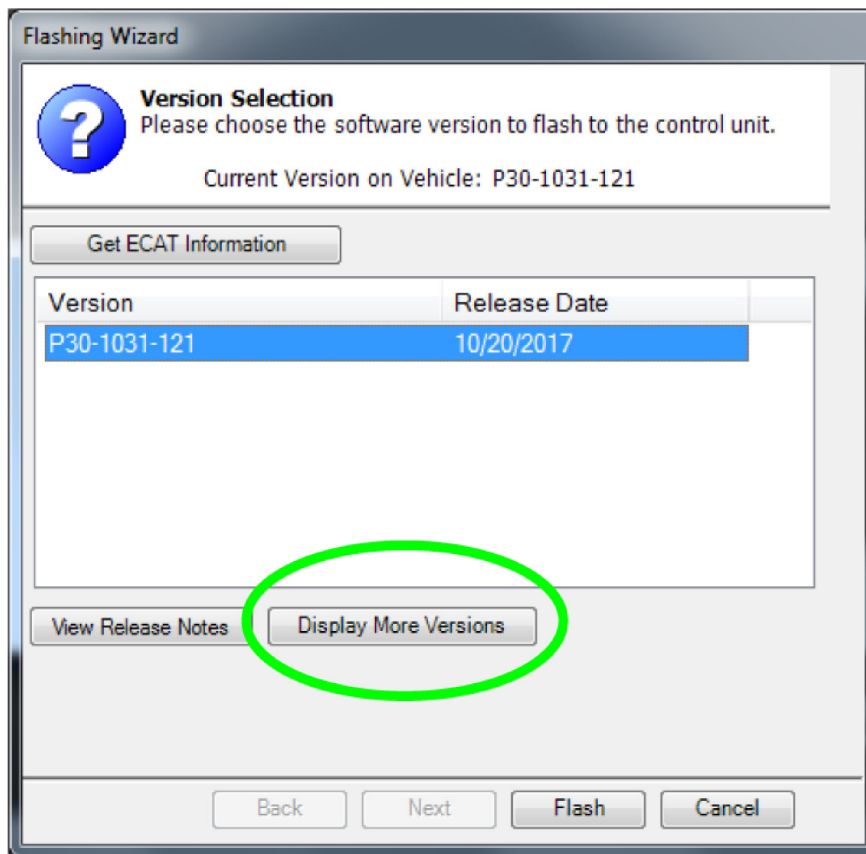
3. A warning message stating the software is old and incompatible will display. Select the **Fix** button next to the warning message.
4. The Flashing Wizard dialog will display. If no software options are shown, select the **Display More Versions** button to display the software options.

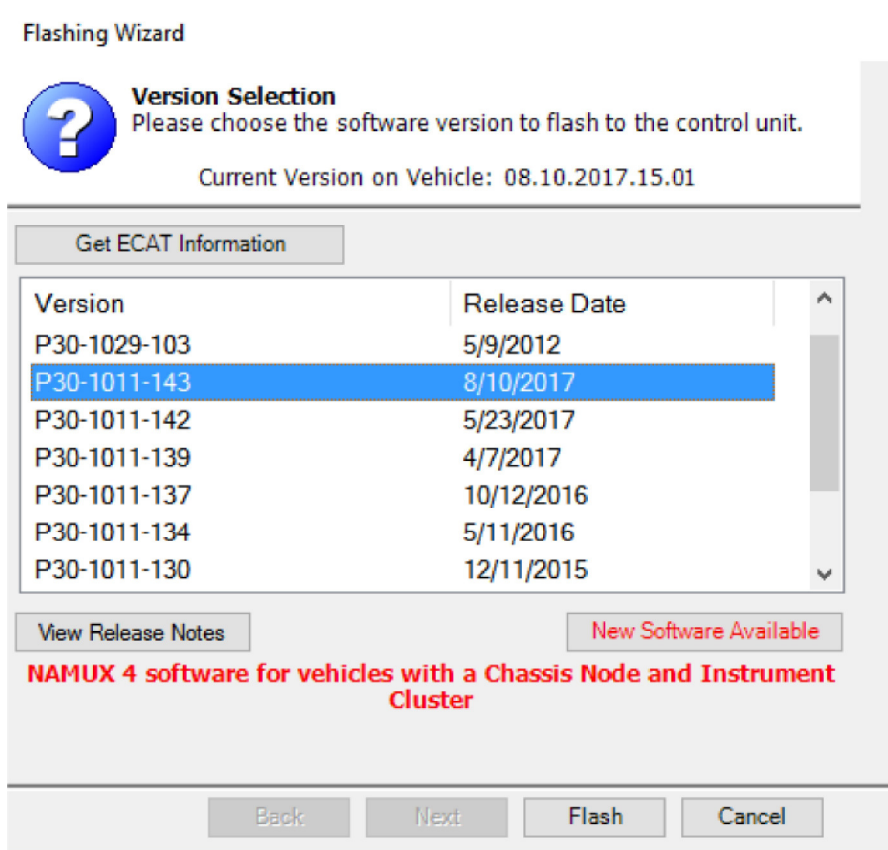
The CECU version installed will be P30-1011-143. The new version is also P30-1011-143. They are different revisions. The revision number of the software version is not visible when looking at the software version.

5. Select **P30-1011-143**, and then select **Flash**.
