154/17 ENU WH74

WH74 - Checking Gap Dimension of Rear Spoiler and Reworking if Necessary (Stop Sale/Workshop Campaign)

Model Line: Panamera Sport Turismo (971)

Model Year: 2018

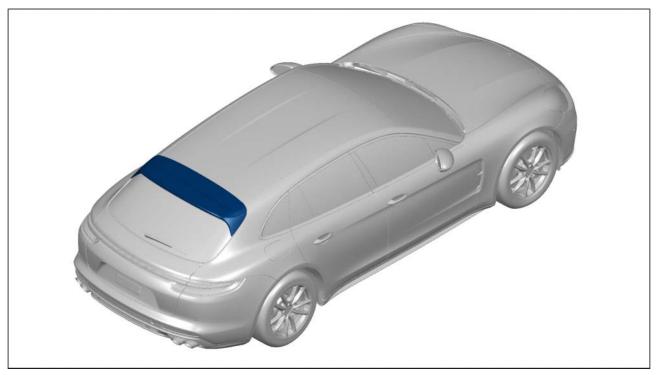
Installation position of rear spoiler

Subject: Gap between rear spoiler and roof

Information: There is a possibility that the gap dimension from the rear spoiler to the roof does not comply

with specifications on the affected vehicles.

Remedial Check gap dimension between rear spoiler and roof and rework if necessary, depending on the result of

action: the check
