**Symptom - Body Exterior - Drains On Rear Panoramic Roof Blocked: Cleaning drains (SY 102/17)**

Model Line: **Macan**

Subject: **Drains on rear panoramic roof**

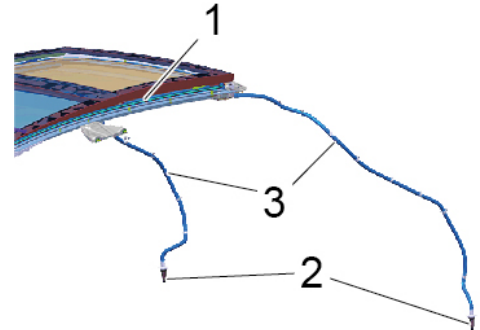
*Drain bush*

- 2 From inside the vehicle, pour water into the guide rails at the left and right (⇒ *Drain bush -1-*) near the glass panel using a commercially available measuring cup.

- 3 If no water flows out at the relevant points ⇒ **Clean water drain hoses**, see description below.

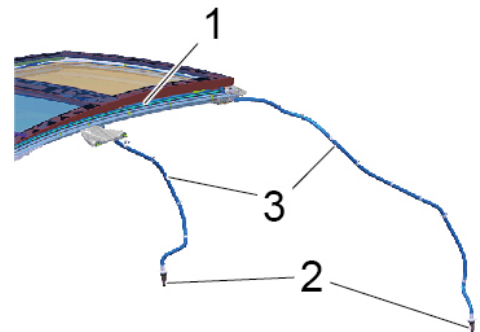
*Drain bush*

Cause: The drains on the rear panoramic roof may be blocked by debris.

- 4 **VAS 6620 - Cleaning and pull-in aid** must be pushed into the drain (vehicle underbody — ⇒ *Drain bush -2-*).

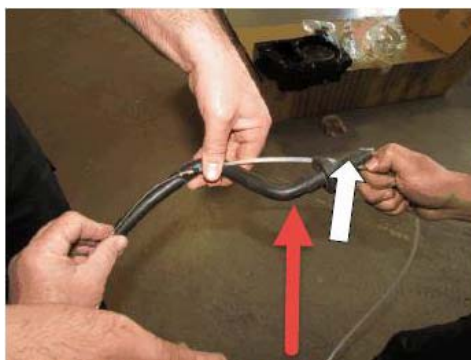
*Water Drain Hose Bends — Work the tool gently in the area of the bends.*

**Important:** When inserting the cleaning tool into the drain, be careful not to insert it too far, too fast, as the tool may damage the drain. The drain bends only a couple inches in from the end.
