L62X-A.02.18

**Subject.**CarPlay Upgrade**Model.**

Huracan Coupe and Spyder;

**VIN Identification.**From VIN JLA06599 to JLA08774

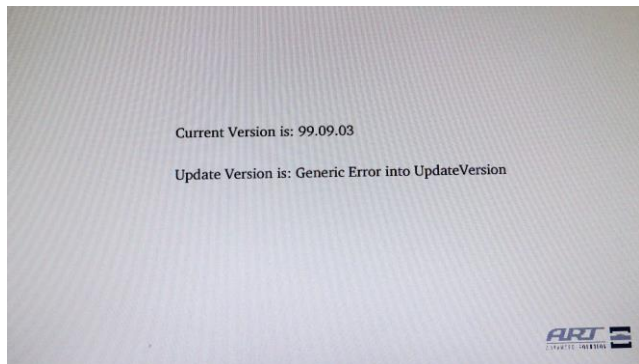
- A. During TSU update procedure, if the following page is shown in MMI display

Quit from “TSU Engineering Menu”, remove USB stick from USB port and then switch ignition Off.

Then switch again ignition On, insert again USB stick into USB port and access again into TSU Engineering Menu.

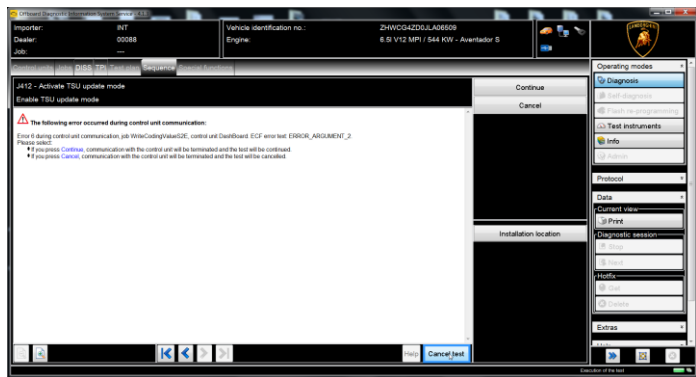
- B. If the following error page is shown, you shall abort the procedure clicking on “Cancel Test” and contact the Technical Support.

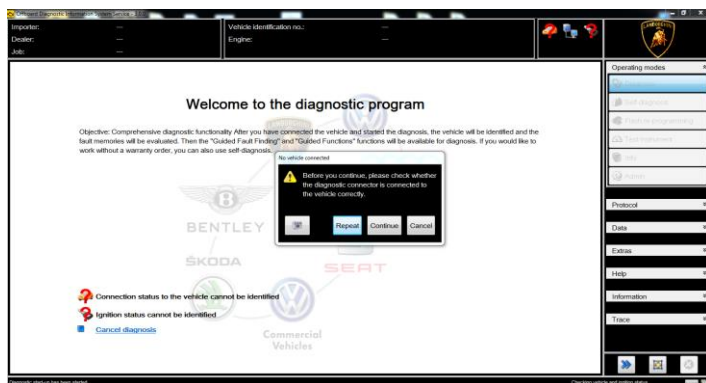
- C. If the error message regarding the VAS5054 interface and the two icons for status of on board connection and key ON are shown as in the picture below:

- Click “Cancel”;
- Repeat the VAS5054 HW interface installation following the procedure (\*) “VCI Manager v2.0”, by entering in the menu “Extras” on the right side and clicking on “Diagnostic interface”.

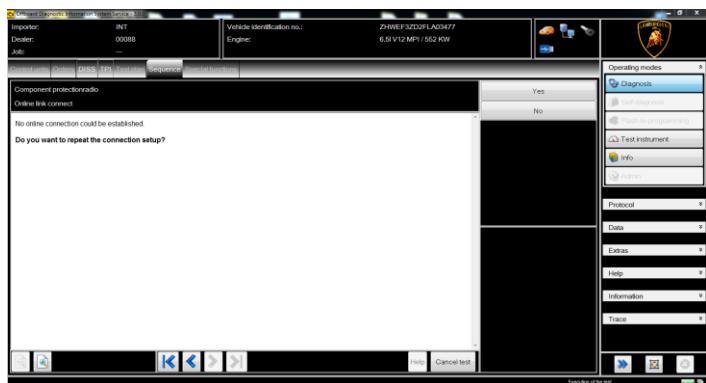
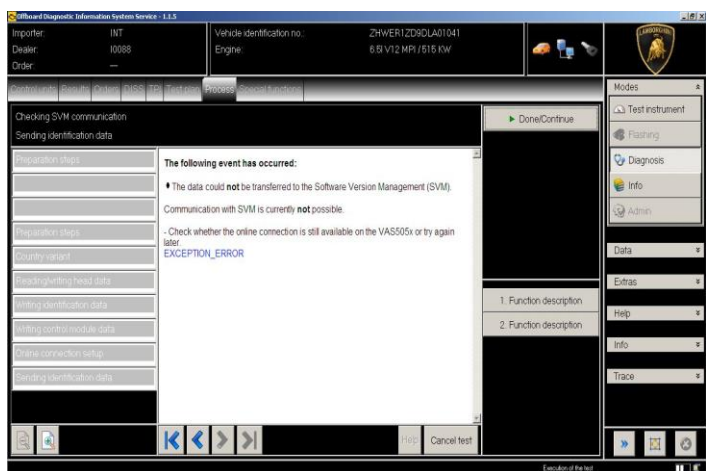
- D. If one of the connection error screens is shown as in the pictures below:

- it is not possible to establish a connection with the central server. Please check carefully that the diagnosis laptop is properly connected to the internet network and retry clicking “Yes” or “Done/Continue”.

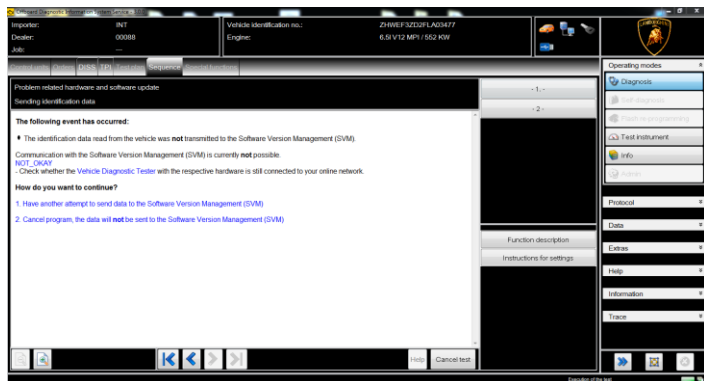
E. If the loss of connection happens during the target/actual comparison during SVM procedure:

- It is not possible to connect to central server, check the working connection of internet and retry by clicking “1”.

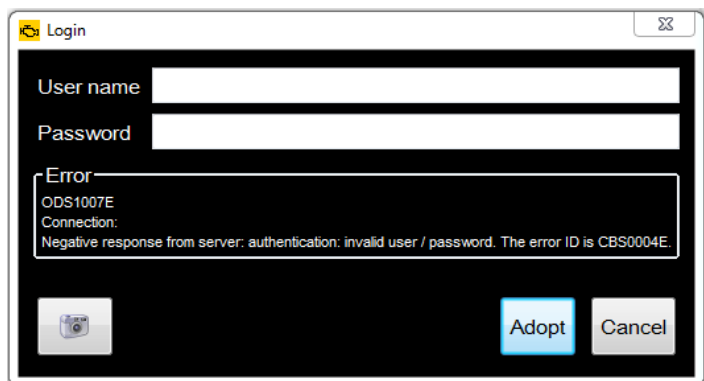
F. If the incorrect identification message is shown as in the picture below (error code: ODS1007E):

- be sure that your Geko account is valid;
- be sure that the label “Geko” is written on the token that you are using for the authentication;
- be sure the Password inserted is correct;
- click on Cancel and perform the application test (see document “ODIS\_Checking\_ConnectionServer\_SVM\_2.0” (\*)).

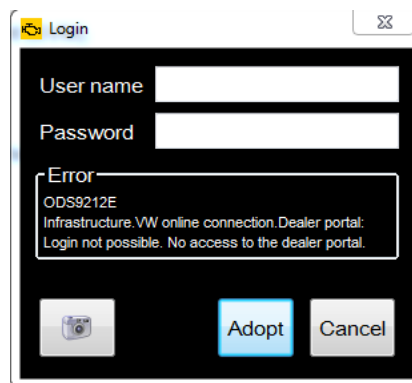
G. If the infrastructure error message is shown as in the picture below (error code: ODS9212E):

- be sure that your Geko account is valid
- be sure that the label “Geko” is written on the token that you are using for the authentication
- verify in ODIS settings you have “Internet” instead of “CPN” (see document “ODIS\_Initial\_Setup\_2.0” (\*))
- click on Cancel and perform the application test (see document “ODIS\_Checking\_ConnectionServer\_SVM\_2.0” (\*))
