**Campaign code.**

L73X-A.02.18

**Subject.**CarPlay Upgrade**Model.**Aventador S Coupè and Aventador Roadster equipped with CarPlay;**Model year.**2017.2018**Special or Limited Versions.**All;**Markets.**

Automobili Lamborghini Spa has released a software update that will provide to activate the CarPlay on cars where this is not active and will correct small operating bugs.

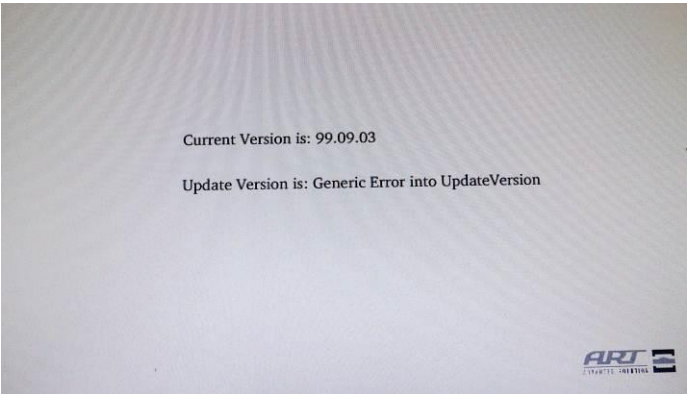
A. During TSU update procedure, if the following page is shown in MMI display:

Quit from “TSU Engineering Menu”, remove USB stick from USB port and then switch ignition off.

Then switch again ignition on, insert again USB stick into USB port and access again into “TSU Engineering Menu”.

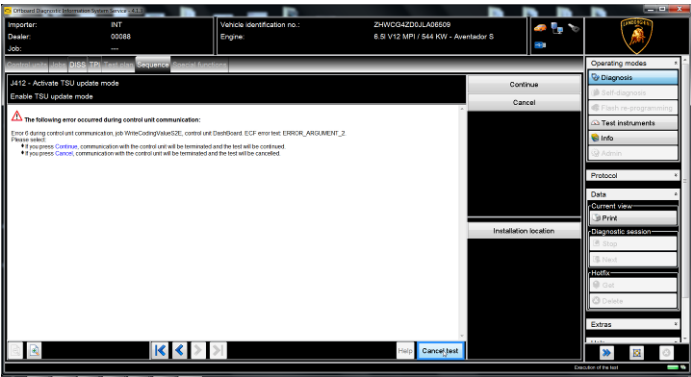
B. If the following error page is shown, you shall abort the procedure clicking on “Cancel Test” and contact the Technical Support.

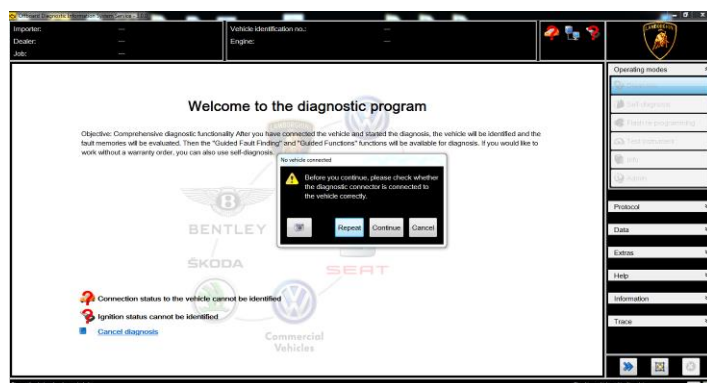
C. If the error message regarding the VAS5054 interface and the two icons for status of on board connection and key ON are shown as in the picture below:

- Click “Cancel”;
- Repeat the VAS5054 HW interface installation following the procedure (\*) “VCI Manager v2.0”, by entering in the menu “Extras” on the right side and clicking on “Diagnostic interface”.

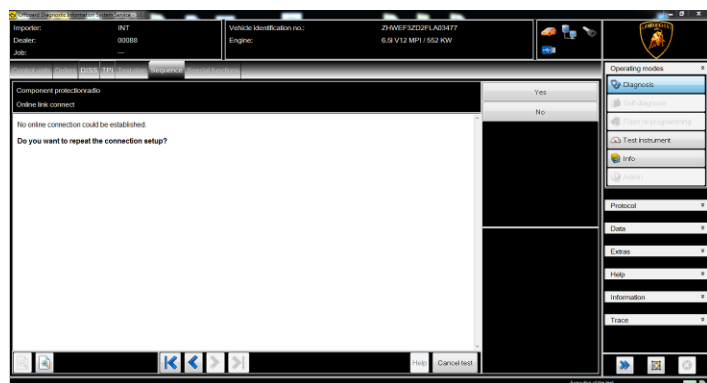
D. If one of the connection error screens is shown as in the pictures below:

- it is not possible to establish a connection with the central server. Please check carefully that the diagnosis laptop is properly connected to the internet network and retry clicking “Yes” or “Done/Continue”.

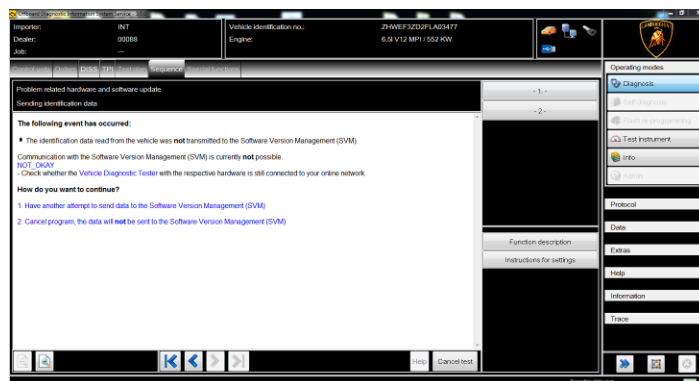
E. If the loss of connection happens during the target/actual comparison during SVM procedure:

- It is not possible to connect to central server, check the working connection of internet and retry by clicking “1”.

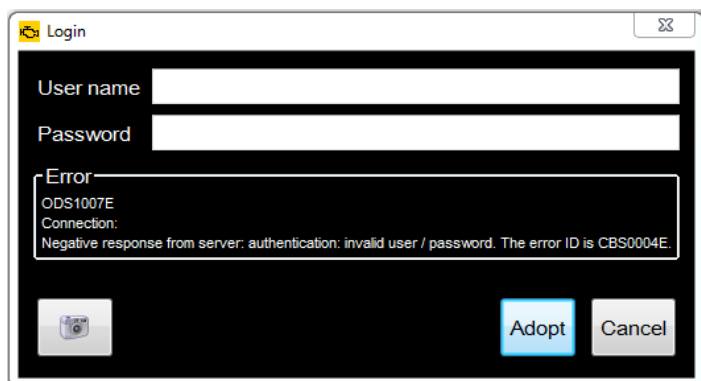
F. If the incorrect identification message is shown as in the picture below (error code: ODS1007E):

- be sure that your Geko account is valid;
- be sure that the label “Geko” is written on the token that you are using for the authentication;
- be sure the Password inserted is correct;
- click on Cancel and perform the application test (see document “ODIS\_Checking\_ConnectionServer\_SVM\_2.0” (\*)).

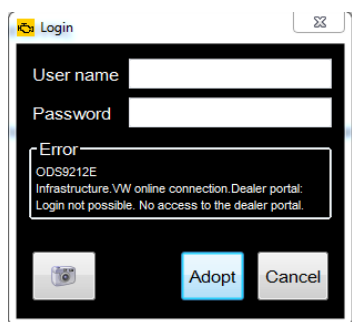
G. If the infrastructure error message is shown as in the picture below (error code: ODS9212E):

- be sure that your Geko account is valid
- be sure that the label “Geko” is written on the token that you are using for the authentication
- verify in ODIS settings you have “Internet” instead of “CPN” (see document “ODIS\_Initial\_Setup\_2.0” (\*))
- click on Cancel and perform the application test (see document “ODIS\_Checking\_ConnectionServer\_SVM\_2.0” (\*))
