L734-A.01.18

**Subject.**CarPlay Activation**Model.**Aventador S Coupè equipped with telemetry system;**Model year.**2017.**Special or Limited Versions.**All;**Markets.**

**VIN Identification.**From HLA04772 to VIN HLA06479.

Automobili Lamborghini Spa has released a software that will activate the telemetry and will also update or activate the CarPlay depending on whether it is already working on the car.

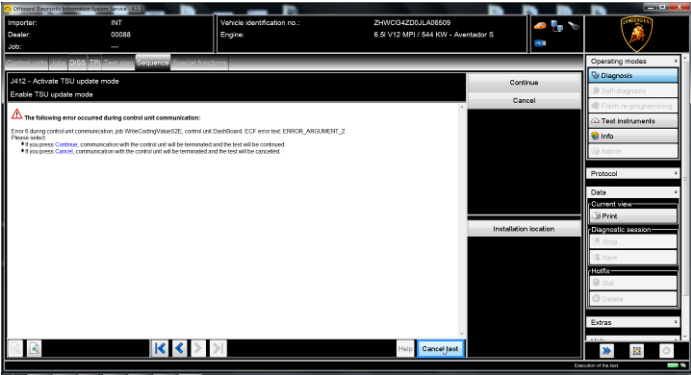
B. If the following error page is shown, you shall abort the procedure clicking on “Cancel Test” and contact the Technical Support.
