February 9, 2018

Version 1

The ACC, LKAS, Road Departure Mitigation, Collision Mitigation Brake System, BRAKE Indicators and/or "Auto High Beam Problem" Message Comes On

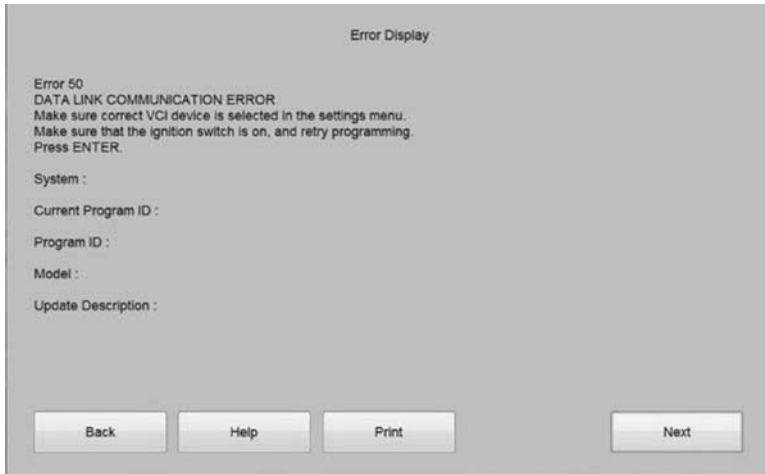
- If you see the following **Error Display**, check that you are using the correct tool (MVCI or DST-i) with the i-HDS.

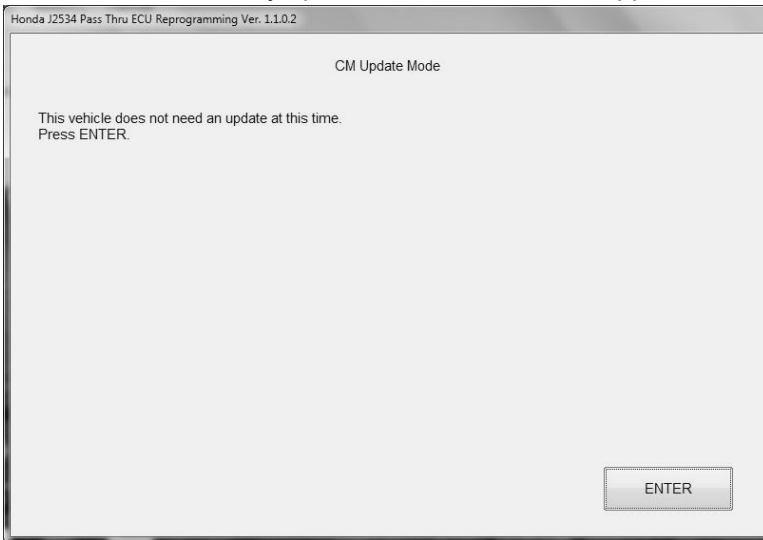
If the camera is already up to date, this screen will appear:
