**February 8, 2018**

## Flickering Lights, Multiple Indicators Coming On, Jerky Steering and/or Voltage-Related Fluctuations

### AFFECTED VEHICLES

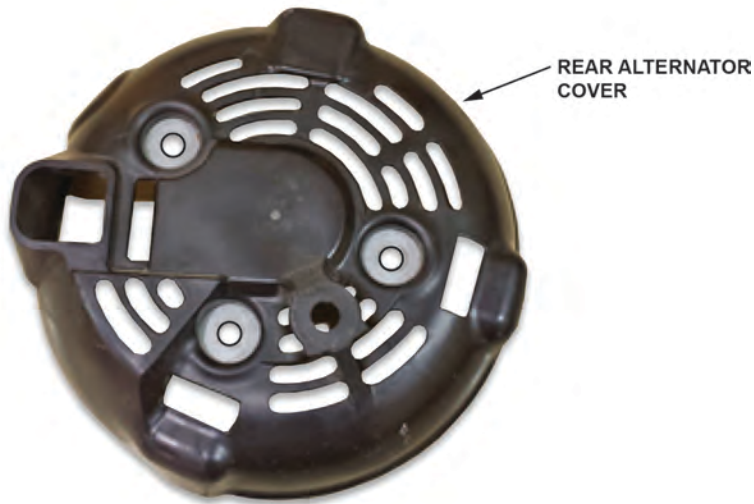
The B+ sensing screw on the alternator is not torqued properly.

1. Disconnect and isolate the negative cable with the battery sensor from the battery. Refer to the service information.
2. Remove the front bulkhead cover if applicable. Refer to the service information.
3. Remove the #4 spark plug ignition coil to give you better access. Refer to the service information.
4. Disconnect the alternator connector.
5. Remove the three 8 mm nuts holding on the rear alternator cover, then remove the cover.
