February 8, 2018

Version 1

Flickering Lights, Multiple Indicators Coming On, Jerky Steering and/or Voltage-Related Fluctuations

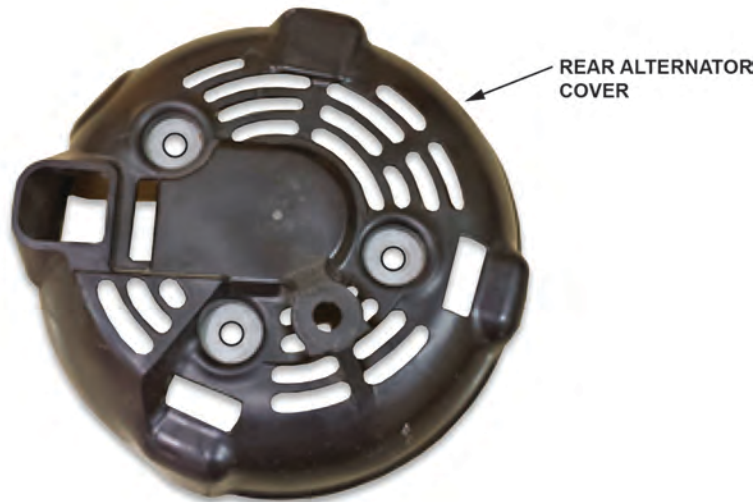
The B+ sensing screw on the alternator is not torqued properly.

1. Disconnect and isolate the negative cable with the battery sensor from the battery. Refer to the service information.
2. Remove the #4 spark plug ignition coil to give you better access. Refer to the service information.
3. Disconnect the alternator connector.
4. Remove the three 8 mm nuts holding on the rear alternator cover, then remove the cover.
