ITB18-004

January 25, 2018

VOLUNTARY SERVICE CAMPAIGN 2018 Q60 SPORT; POWER STEERING CONTROL MODULE REPROGRAMMING

CAMPAIGN ID #: P8301**APPLIED VEHICLES:** 2018 Q60 Sport (V37) equipped with RWD
2018 Q60 Red Sport (V37) equipped with RWD

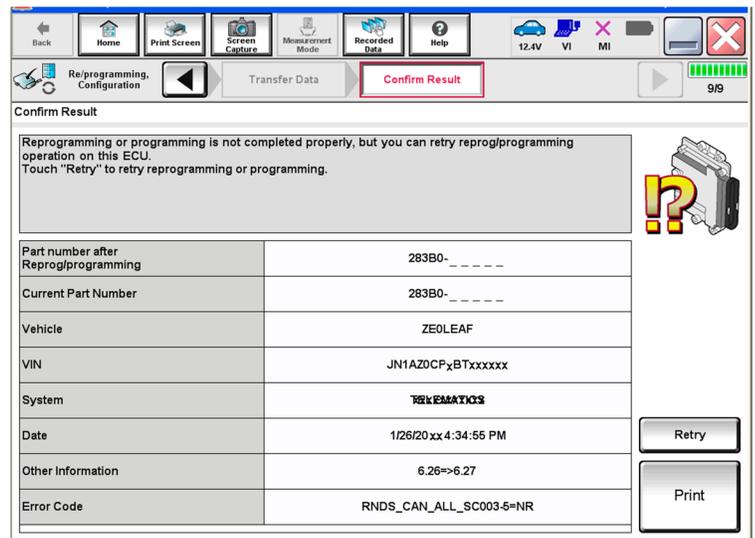
Figure 25

If reprogramming does not complete and the “!?” symbol displays as shown in Figure 25:

- Check battery voltage (12.0 – 15.5V).
- Ignition is ON.
- External Bluetooth® devices are OFF.
- All electrical loads are OFF.
- Select **Retry** and follow the on screen instructions.

NOTE: Retry may not go through on first attempt and can be selected more than once.

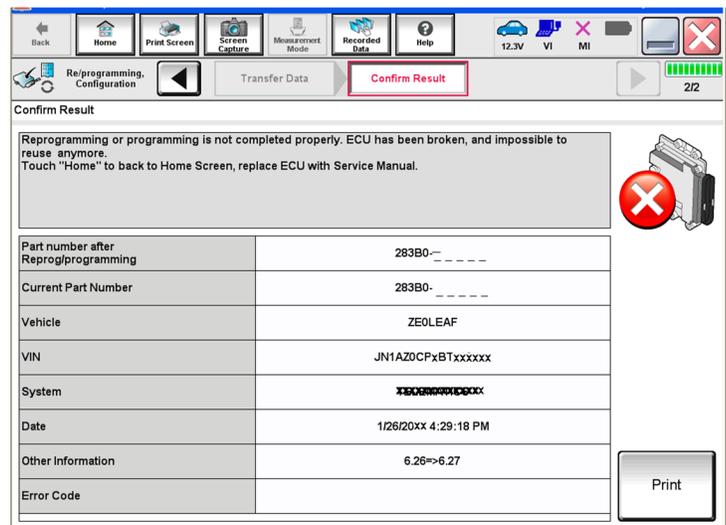
Figure 26

If reprogramming does not complete and the “X” symbol displays as shown in Figure 26:

- Do not disconnect the plus VI or shut down C-III plus if reprogramming does not complete.
- Check battery voltage (12.0 – 15.5V).
- CONSULT A/C adapter is plugged in.
- Ignition is ON.
- Transmission in Park.
- All C-III plus / plus VI cables are securely connected.
- All C-III plus updates are installed.
- Select **Home**, and then restart the reprogram procedure from the beginning.
