Title (customer effect) Volvo Chassis - Equipped With Volvo Active Driver Assist (VADA), With Or Without Lane Departure Warning (LDWS) - Diagnostic Trouble Code (DTC) SPN 516103 FMI 19, Bendix Code 167 With Possible "Lane Departure Warning Malfunction" Message - US17 And Newer

Cause Volvo Chassis equipped with Volvo Active Driver Assist may display DTC / Fault code SPN 516103 FMI 19 on Premium Tech Tool (PTT) or J-Pro, and code 167 in Bendix ACOM software.

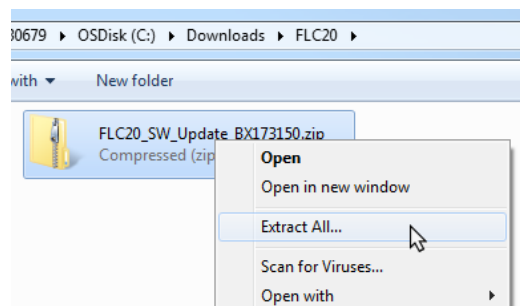
- A. Right-click on the ZIP file and select "Extract All..."

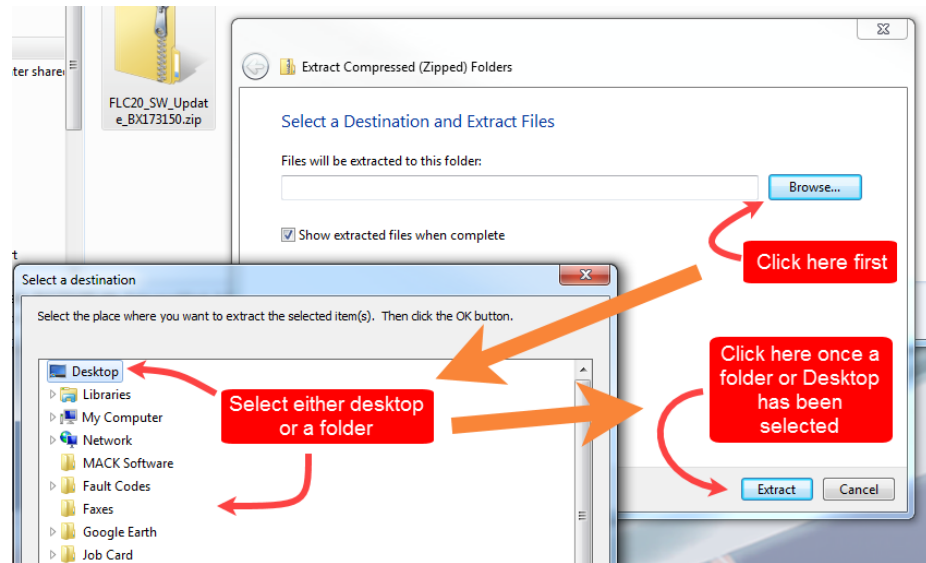
B. Click the Browse button and pick either Desktop or another folder where the file can be easily found. Click the OK button once the folder is picked, then Click the Extract button.

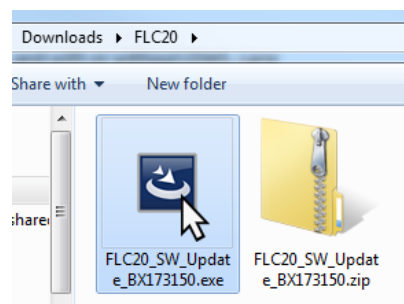
3. Double-click the executable file to run the update software:

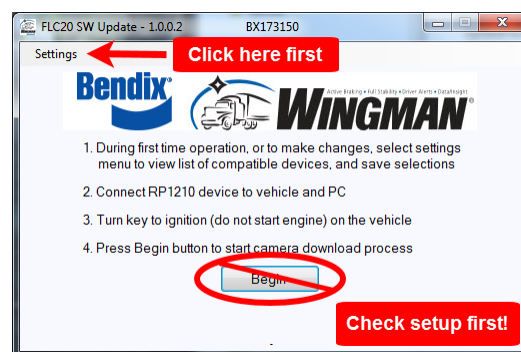
4. The program screen will open. Before clicking Begin, open the Settings menu:

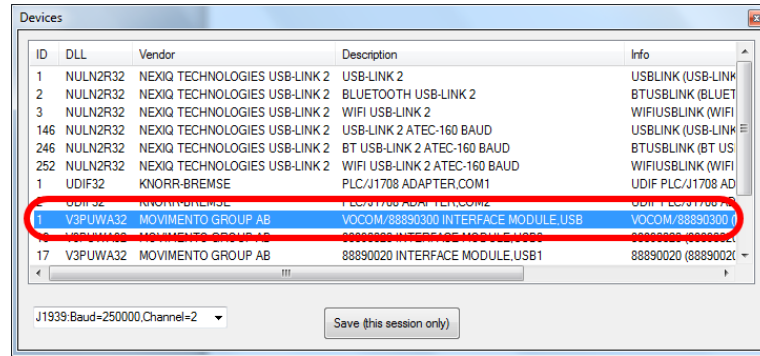
A. Choose the Vocom adapter from the list as shown below:

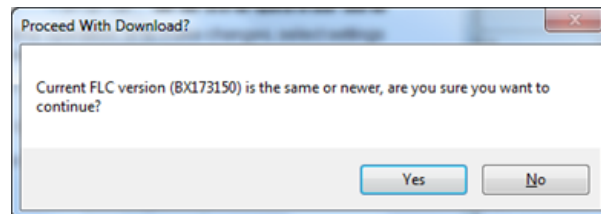
NOTE: If the error message shown below appears, the module software does not need to be updated.
