Title: LT with 0008XHH BTR Battery box harness rub

Applies To: LT

This document will guide the user through correcting concern of the Center Chassis Harness rubbing between the rail battery box.

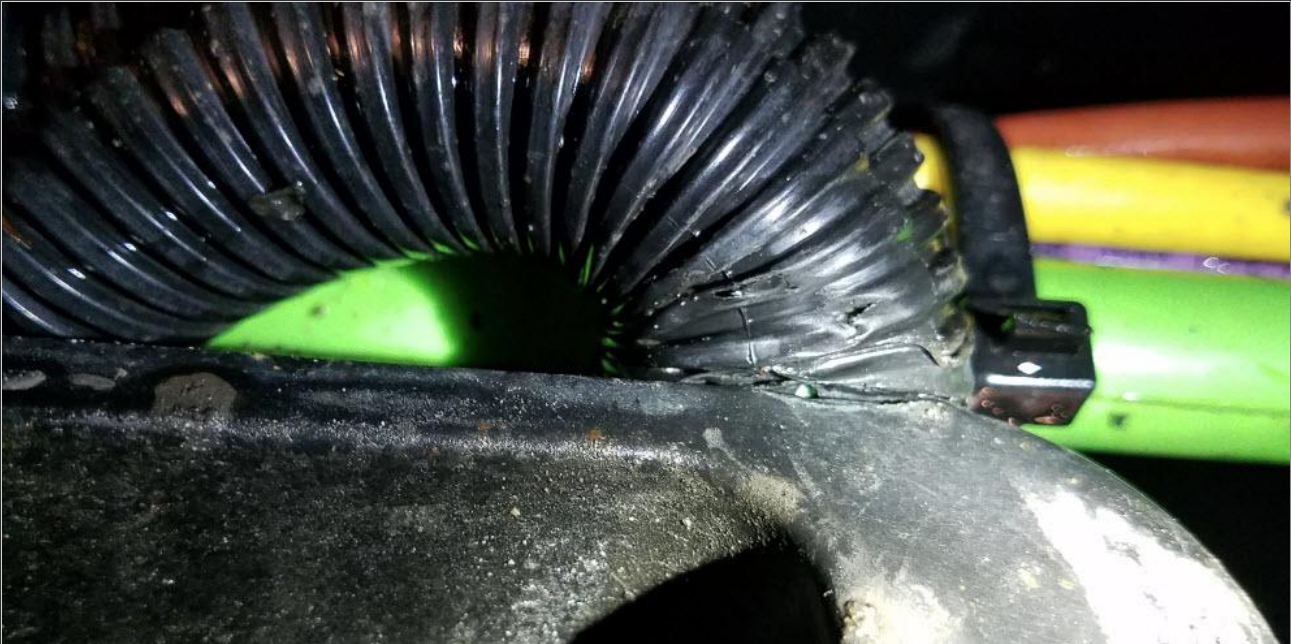
### **Inspect Center Chassis Harness Routing**

ABS light on in dash, rubbed though Center Chassis Harness or harness Loom.

Check Center Chassis Harness location at battery box for contact in bends of the harness as shown

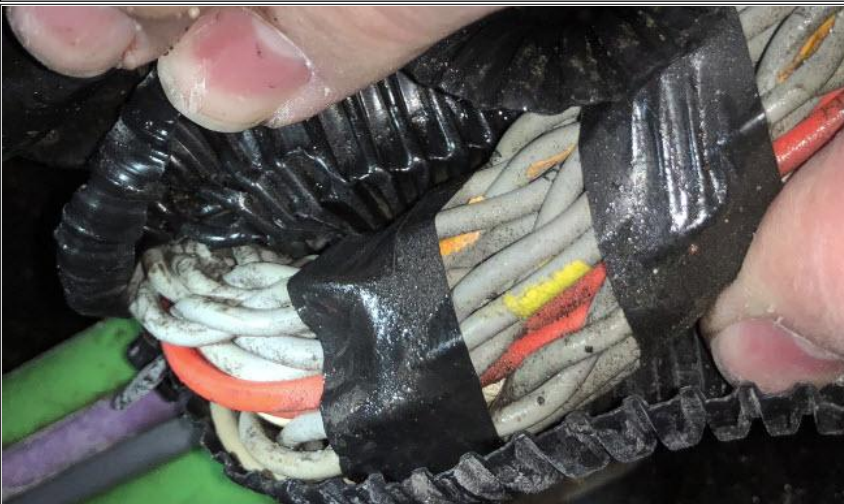
### **Inspect Center Chassis Harness Wiring**

Pull convolute open to check for chaffed or damaged wiring, if wiring is damaged overlay damaged wiring.
