Title: IC Bus with ISB Frequent Regeneration

Applies To: IC Bus ISB

This document will guide the user through resolving Frequent Regen issues on IC Bus with ISB 6.7.

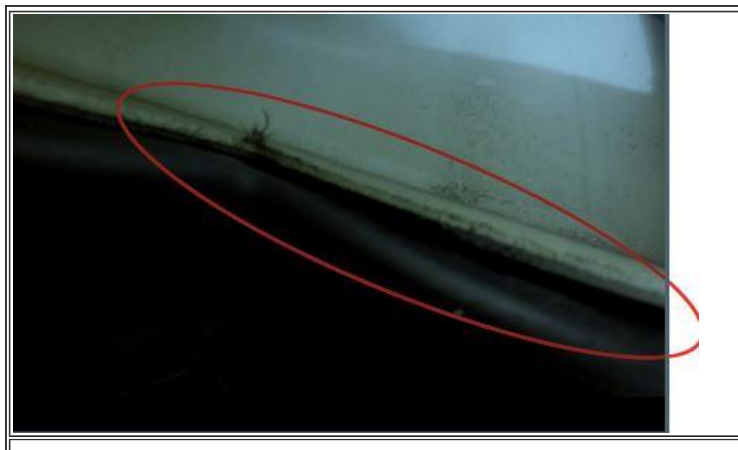
1. Airbox boot seal to the hood compromised. Middle section may appear bent or folded in. The seal position looks off-centered from the hood.

Figure 1: Gap between Boot seal and Hood

Step	Action	Decision
2	<p>DIAGNOSTIC:</p> <p>With the hood in the fully latched position, inspect the accordion boot seal to hood. See Figure 1 and 2</p> <p>Is a gap present between the seal and hood?</p>	<p>Yes. Replace the cover assembly.</p> <hr/> <p>No. Return to Fault Codes Diagnostics</p>

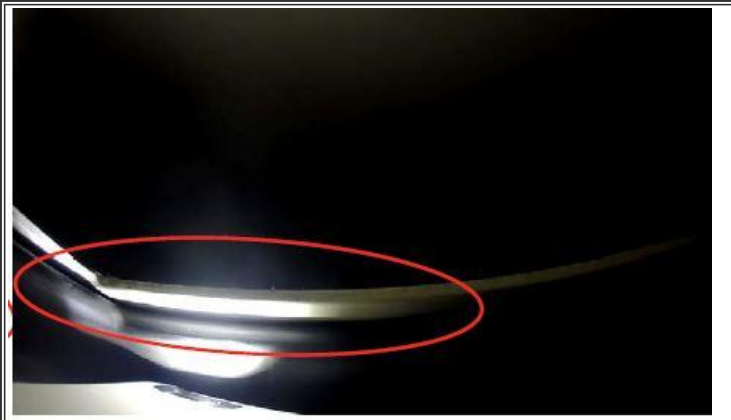
Figure 2: Hood misaligned with respect to Boot seal
