**Countries:** CANADA, UNITED STATES, MEXICO **Document ID:** IK1300159  
**Availability:** ISIS, NotSIR **Revision:** 2  
**Major System:** TRANSMISSION **Created:** 9/28/2017  
**Current Language:** English **Last Modified:** 1/2/2018  
**Other Languages:** NONE **Author:** William Katschke  
**Viewed:** 515

**Title:** LT Fuller Advantage Series Transmission Power and Ground

**Applies To:** LT w/ A26 & X15

This document will provide the user with Fuller Advantage Series (FAS) Automated Transmission power and ground circuit information.

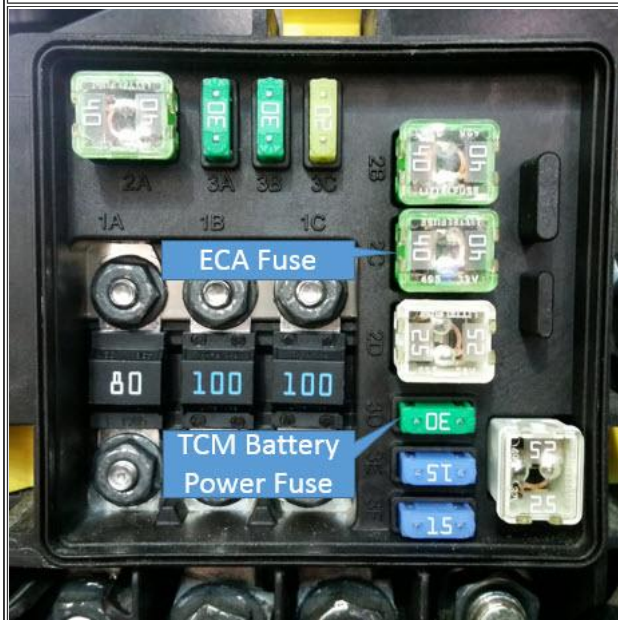
Figure #2: Under Hood PDM

1. While performing Eaton diagnostic steps be sure to inspect the power and ground connections at the Underhood PDM and the Ground Stud located by the engine starter.
2. Ensure the connections are clean (free of corrosion) and tight, Ground Stud Torque (43 N-m (31.7 ft-lb.)).

1. Clean and tighten any loose connections.
2. Clearly document in RO, with Road Ranger, and or Navistar tech service if loose connection was found.
3. Clear DTC's in all modules.
