**Countries:** CANADA, UNITED STATES **Document ID:** IK1600241  
**Availability:** ISIS, NotSIR **Revision:** 0  
**Major System:** CAB / SLEEPER / HOOD **Created:** 12/20/2017  
**Current Language:** English **Last Modified:** 1/16/2018  
**Other Languages:** NONE **Author:** William Katschke  
**Viewed:** 96

**Title:** LT Front Bumper Rock Guard Corrosion**Applies To:** LT

This document will guide the user through steps to take when rust/corrosion is found around the rock guards on the LT front bumpers.

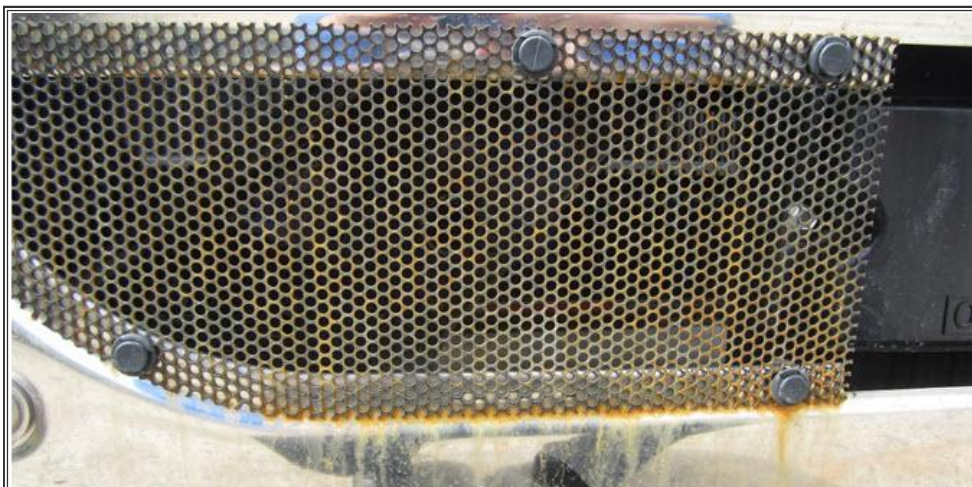
Rust/Corrosion found around the rock guards on the LT front bumpers, see figure 1 below.

**Figure #1: Rust/Corrosion on the Front Bumper Rock Guard**

1. If the rock guard shows signs of rust/corrosion as shown in Figure #1:

1. Remove the rock guard
2. Clean bumper
3. Install new rock guard

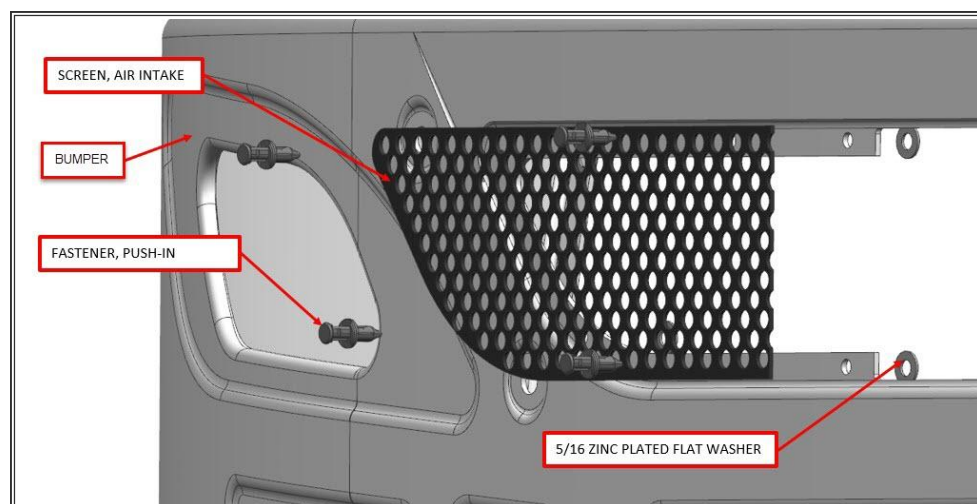
**Figure #2: Front Bumper Rock Guard Component Locations**
