**Document ID:** IK2200070  
**Revision:** 9  
**Created:** 4/30/2008  
**Last Modified:** 1/30/2018  
**Author:** Brandon Akridge

**Title:** Bus Body Tie Down, Floor Sill Repair

**Applies To:** All Bus Models

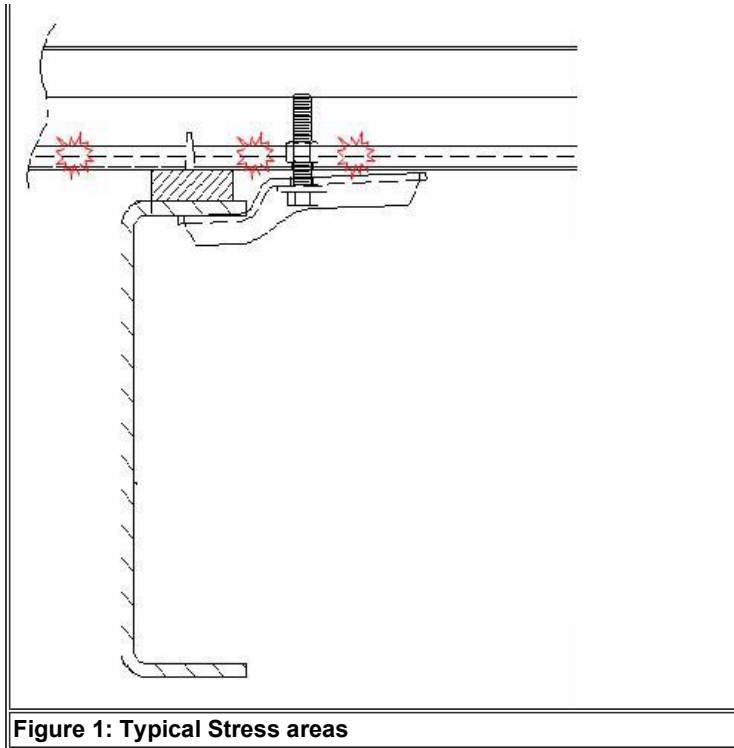
**Figure 1: Typical Stress areas**

Floor sill damage at the body tie down point can be caused by improper adjustment, a missing anti-squeak pad, or a tie down placed on the opposite main sill flange as the anti-squeak pad. Loose or over tightened tie downs (formed clip, J-bolt or u-bolt) will cause excessive stress to the floor sill flange resulting in deformities and/or eventually a fatigue crack.

The following kits are available to reinforce the floor sill flange area to restore proper body tie-down strength. The floor sill reinforcement kits are welded to the existing main floor sill to repair and reinforce the tie down area. Weld instructions are included with each kit.
