Service Category	Drivetrain		
Section	CVT	Market USA	Scion Supports

YEAR(S)	MODEL(S)	ADDITIONAL INFORMATION
2016	iM	Transmission(s): CVT

Some 2016 model year iM vehicles may exhibit a MIL "ON" condition with Diagnostic Trouble Code (DTC) P2820 present, indicating a Pressure Control Solenoid (shift solenoid valve SLP) Performance condition. The Engine Control Module (ECM) (SAE term: Powertrain Control Module/PCM) logic has been updated to prevent this condition. Follow the Repair Procedure below to address this condition.

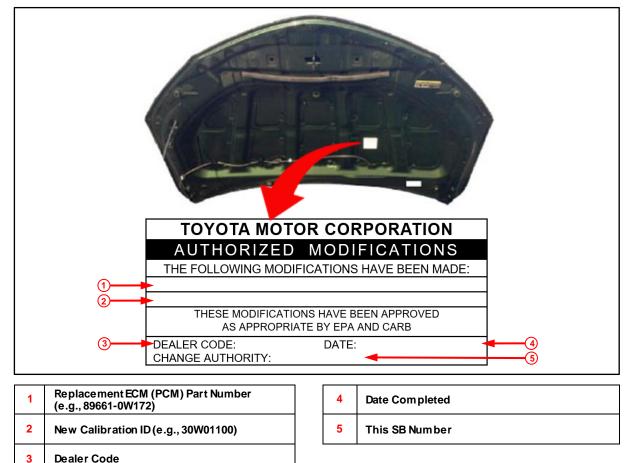
#### Figure 1. Location of Authorized Modifications Label for 2016 iM

4. Check for the Authorized Modifications Label affixed to the vehicle in the location shown below. Confirm if the ECM (PCM) calibration has been updated.

- 6. Prepare and install the Authorized Modifications Label.
  - A. Using a permanent marker, enter the following information on the label:
    - ECM part number [Refer to the **Parts Information** section for the **NEW PART NUMBER**]
    - Calibration ID(s) [Refer to the Calibration Information section for the NEW CALIBRATION ID]
    - Dealer Code
    - Repair Date
    - Change Authority [This bulletin number]
  - B. Install the Authorized Modifications Label on the vehicle at the location shown in Figure 1. The Authorized Modifications Label is available through the MDC, P/N 00451-00001-LBL.
- 7. Perform the Techstream ECT Reset Memory Utility.
- 8. Test drive the vehicle to confirm the repair.
