Subject Front Door Lower Exterior Molding Gap		Market USA
Service Category Vehicle Exterior	Section Door/Hatch	
Applicability 2017-Present Highlander / HV2018 Highlander / HV

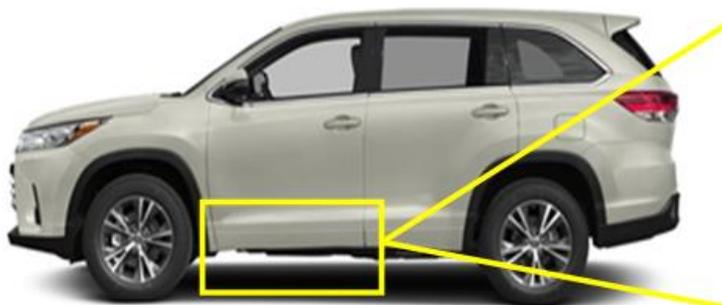
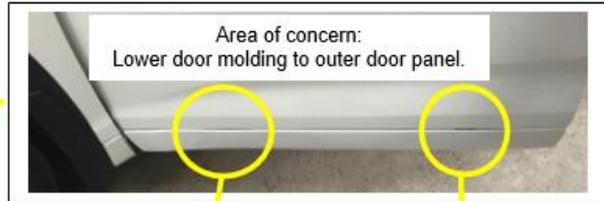
Some vehicles may experience a condition in which the LH or RH front door outside molding exhibits a gap, looseness or separation from the outer door panel.

Please document the following during diagnosis and repair of the vehicle and submit a DPR:

- Overall photograph of affected door.
- Location of gap, looseness or separation between door molding and outer door panel.
 - Photograph door with masking tape to mark location of gap and measure distance from front of door to center of gap location.
- Inspect installation condition of molding retaining clips during disassembly.
 - Photograph location of clip(s) damaged or improperly installed into molding and/or outer door panel. If photo is unavailable, include description of clip installation condition.
 - Include measurement of distance from front of door to affected clip(s).
- Inspect double sided tape condition during disassembly.
 - Photograph tape condition in affected area for signs of dust or separation of tape.
