MODEL: Karma Revero

TITLE: Radiator Hose Clamp Inspection

# Technical Service Bulletin

**TB-18-20-01**

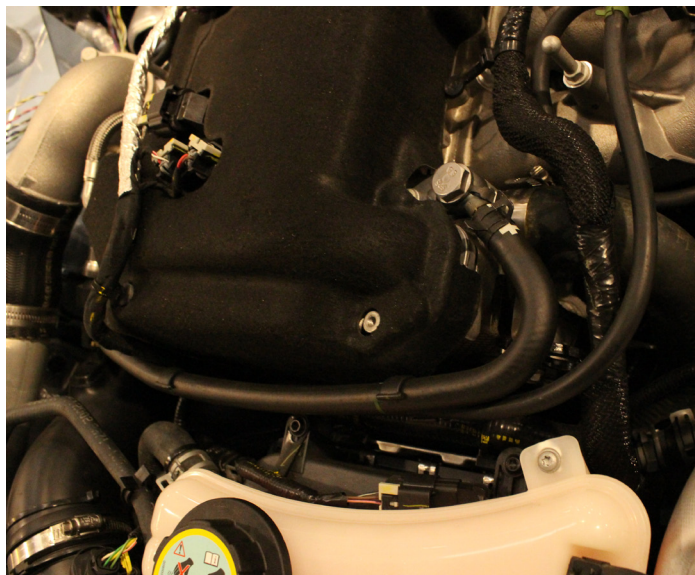
fig 1a

Any vehicle in for service should have the worm drive clamp inspected and set to proper torque as specified. If a vehicle presents leaking coolant from the engine bay, use the following procedure to address the leak. If the leak source is found at engine upper radiator hose (fig 1a) connecting to engine coolant port. Again if it is fitted with a worm drive clamp as shown (fig 1b) **torque to 5.5Nm**. Verify leak is no longer present.

If the vehicle is fitted with a constant tension clamp on the hose, or if the worm gear clamp continues exhibiting the leak concern, replace this with hose and clamp assembly part number C131111401004. Provide images of the hose and clamp location for this concern to TSS.
