Service Bulletin No. 459

| <small>MODEL</small> D Series | <small>TYPE</small> Field Change Program | <small>SECTION/GROUP</small> 8-Engine | <small>DATE</small> Jan. 26, 2018 |
| <small>SUBJECT</small> TAILPIPE AND BUMPER SHIELD | | | |

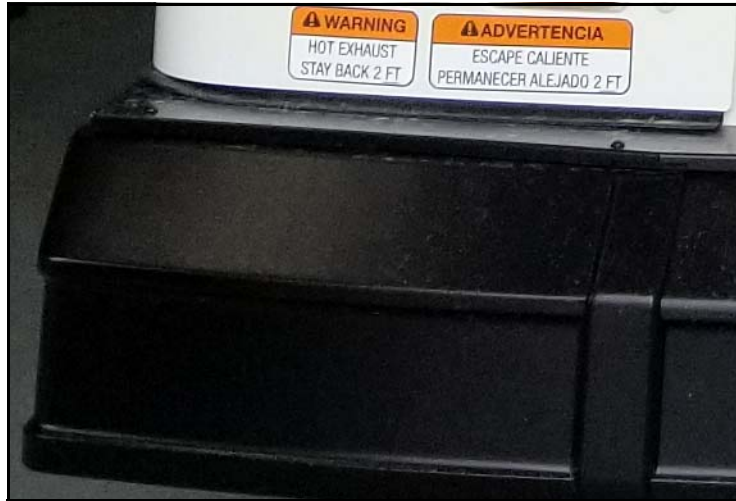
As detailed in the MCI Maintenance Manuals in addition to the decal on the roadside rear bumper, do not park the coach with the rear bumper within two feet of a barrier or obstruction.

Figure 1. Hot exhaust warning decal.

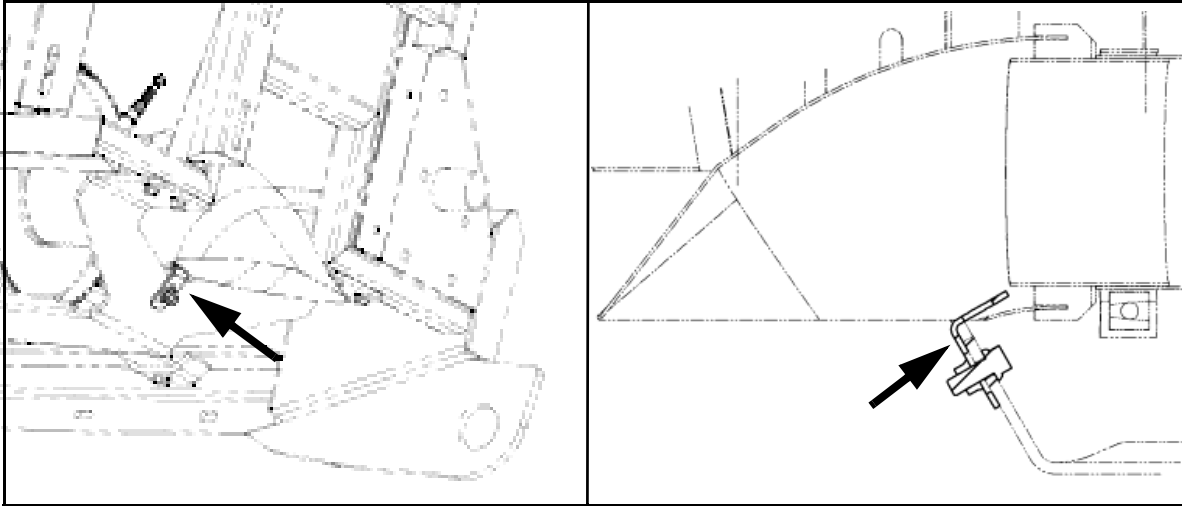
Figure 3. Tailpipe support bracket positioning.

8. Orient and position the short flange of the bracket, p/n 08-01-1043, inside the tailpipe as shown in Figures 2 and 3. Using the hole in the bracket as a drilling template, mark the location of the hole with a scribe or marker.
9. Using a 0.438 drill bit, drill a hole. Secure the installation with the capscrew and locknut. Torque the locknut to 40-44 ft-lbs.
