Technical Service Bulletin

Subject:

KNOCKING / SQUEAKING NOISE FROM FRONT SHOCK ABSORBER, CREAKING NOISE FROM FRONT LOWER ARM BUSHING Bulletin No.: 02-002/18

Last Issued: 01/05/2018

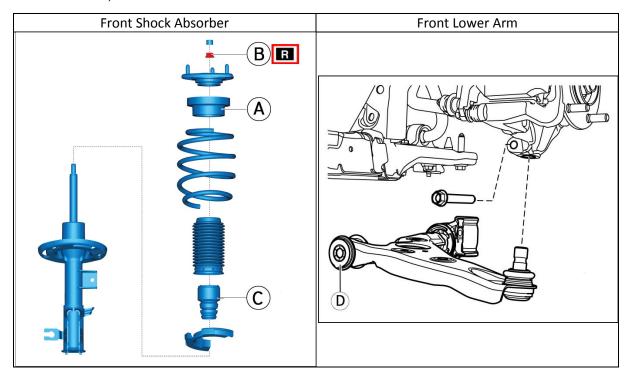
The noise may be due to:

- Upper front strut bearing (A) damage. (CX-5 and Mazda6)
- Squeak type noise between the front strut bearing and coil spring. (CX-3, CX-5 and Mazda6)
- The bump stopper (C) may be contacting the strut bearing when the front shock absorber is compressed, causing a popping noise. (Mazda6 only)
- The front lower arm bushing (D) is making a creak type noise in wet road conditions. (CX-5 and Mazda6).

To eliminate the noise, the following mass-production changes have been made:

- 1. The material and production method of the front strut bearing (A) has been changed. (CX-5 and Mazda6)
- 2. A protector has been installed onto the coil spring. (CX-5 and Mazda6)
- 3. The shape of the bump stopper (C) will be modified in the future. (Mazda6 only)
- 4. The shape of the coil spring has been changed. (CX-3 only)
- 5. Friction of the lower arm bushing has been reduced by adding a dry coating. (CX-5 and Mazda6).

NOTE: The piston rod nut (B) requires replacement.
