| Subject: MAZDA CONNECT REBOOTS OR SCREEN TURNS BLACK DURING COLD TEMPERATURES | Bulletin No.: 09-001/18 |
| | Last Issued: 01/08/2018 |

| 2014-2018 Mazda3 | 2016-2017 CX-3 |

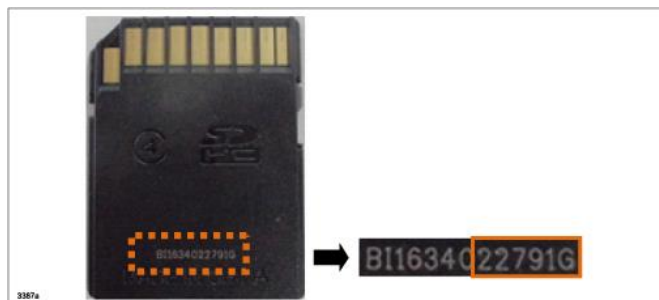
Some customers may experience the MAZDA CONNECT rebooting or the screen turning black during cold temperatures. The concern occurs when the interior of the vehicle is cold and disappears when the interior warms up. This is caused by some for the MAZDA CONNECT navigation system SD cards being manufactured with improper hardware, resulting in a data reading error during cold temperatures. To correct the concern, the SD card hardware has been changed.

1. Verify customer concern.
2. Remove the SD card and check the last 6 digits of the lot number on the SD card.

- If the SD card has any of the following 6 digit lot numbers, replace it with a new SD card.

| 50424D | 50631D | 50635G | 50881G | 50955G |
| 50428G | 50632G | 50877D | 50913D | 50995G |
