Subject: VOICE RECOGNITION SYSTEM DOES NOT RECOGNIZE "ADDRESS" OR "NEW DESTINATION" NAVIGATION VOICE COMMANDS	Bulletin No.: 09-003/18
	Last Issued: 01/10/2018

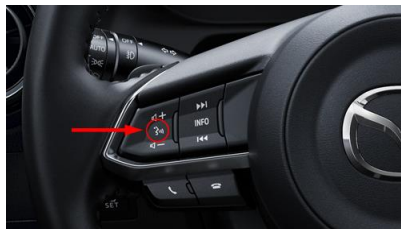
Some customers may complain that the Voice Recognition system does not recognize "Address" or "New Destination" navigation voice commands. This may be caused by faulty navigation SD card software. The SD card has been updated to eliminate this concern.

Customers having this concern should have their vehicle repaired using the following repair procedure.
