Technical Service Bulletin

A/C BLOWS WARM AIR DUE TO REFRIGERANT LEAK FROM CONDENSER

Bulletin No.: 07-001/18

2016-2017 CX-3 vehicles with VINs lower than JM1 DK ****** 158284 (produced before October 21, 2016)

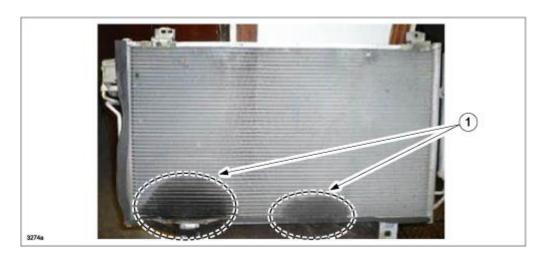
Some customers may complain about warm air from the climate control vents when the air conditioner is ON. This may be caused by condenser corrosion, causing a refrigerant leak.

- 1. Verify the customer concern.
- 2. Visually inspect the condenser for A/C refrigerant leak.
 - Is there a visible trace of A/C refrigerant leaking at location (1)?

- Yes Go to step 4.
- No This Service Information is not applicable. Refer to MGSS online Workshop Manual (NO COOL AIR [FULL-AUTO AIR CONDITIONER]).
- 4. Replace the condenser according to the instructions on MGSS online (CONDENSER REMOVAL/INSTALLATION [SKYACTIV-G 2.0]).
- 5. Verify the repair.
