Technical Service Bulletin

Mazda North American Operations
Irvine, CA 92618-2922

| Subject: EXCESSIVE OPERATING NOISE WHEN SLIDING FRONT POWER SEAT(S) | Bulletin No.: 09-005/18 |

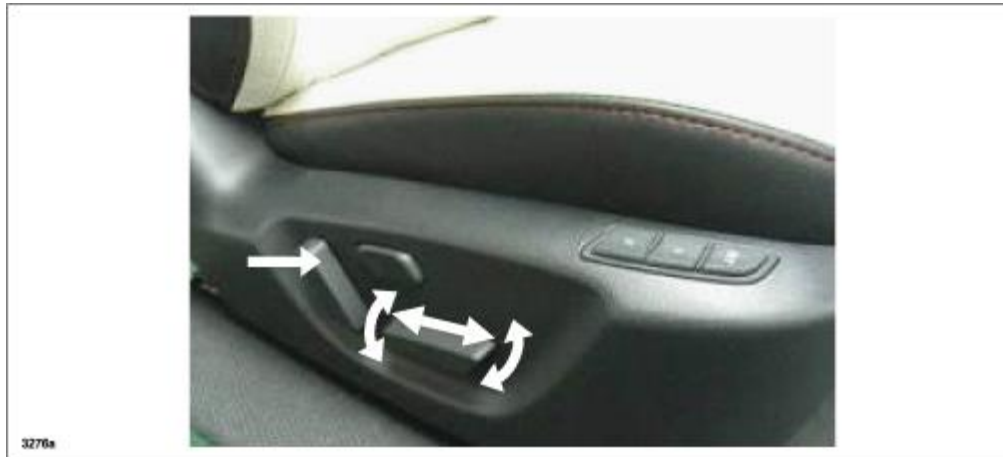
- The repair procedure below is explained using a RH drive model, so the images are shown in reverse.
- To show the cable layout more clearly, the images are shown with the seat cushion removed from the seat frame, however, it is not necessary to remove the seat cushion for this repair.
- Replace the power seat cable with a modified part, only on the seat(s) that are making noise.

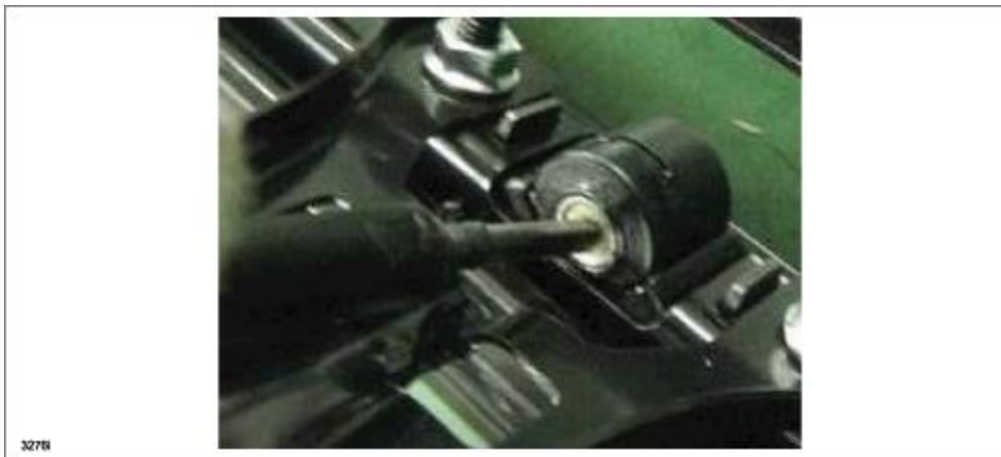
CAUTION: If the cable is bent too much during installation, operation noise may occur. DO NOT hold around the tip of the cable.
