Technical Service Bulletin

NOISE FROM REAR BRAKES DUE TO BRAKE DRAGGING

Bulletin No.: 04-001/18

Last Issued: 01/29/2018

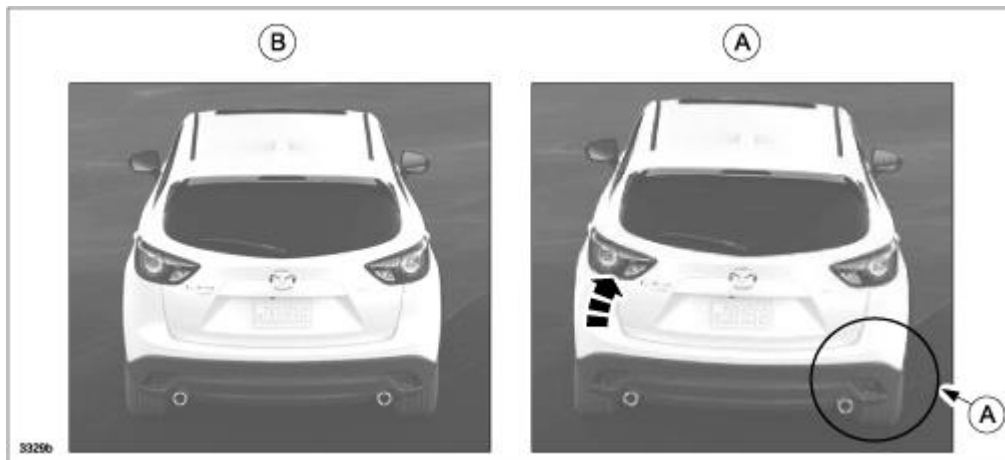
- If the vehicle rolls momentarily to one side, the rear caliper of that side is defective. Go to Step 7.
- If the vehicle does not roll, the EPB automatically released correctly. Go to next step.

NOTE: In the example below, vehicle (B) rolls straight; both rear wheels release at the same time. Vehicle (A) does not release both rear wheels at the same time and the vehicle rolls to one side (A). The EPB released late / incorrectly

7. If the caliper(s) has been found to be defective by the diagnosis procedure, replace the affected side caliper(s) with a modified one(s) according to the instructions on MGSS online:

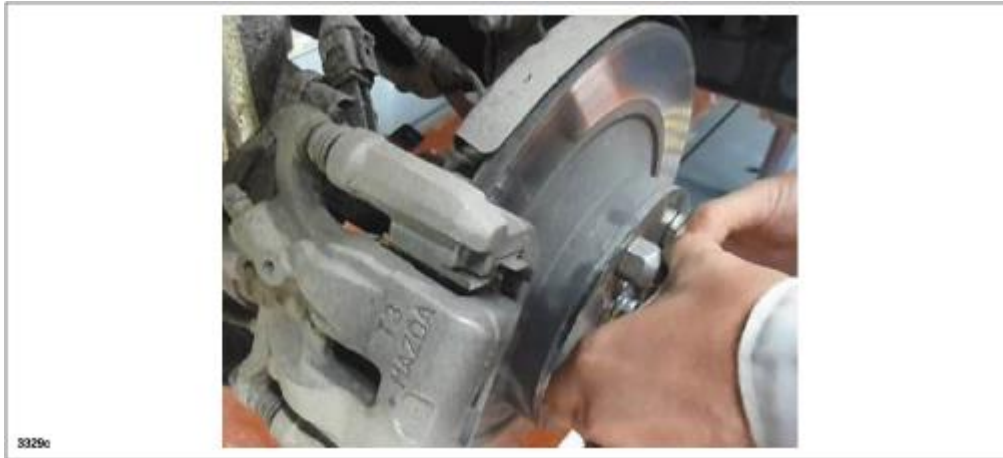
- Lift the vehicle on a hoist and remove the rear wheels.
- Depress the brake pedal firmly and turn the EPB ON with the switch.
- Depress the brake pedal and turn the EPB OFF.
- Verify that that rear disc plates can be easily rotated by hand (as shown below).

- If the rear disc plate does not rotate (or is difficult to rotate) by hand, that side caliper is defective. Go to Step 7.
- If the both disc plates rotate smoothly, go to the next step.

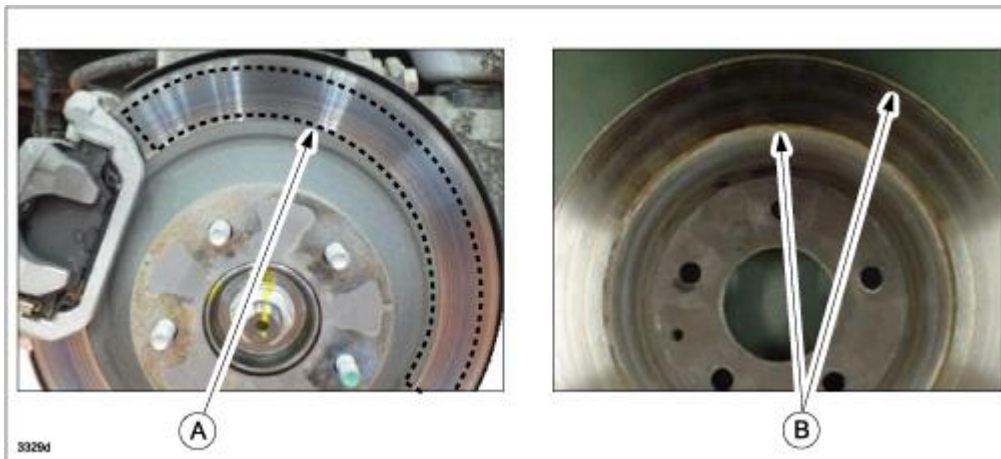
DISC PLATE INSPECTION

5. Inspect the disc plates for bluish black discoloration (A) or whitened damage (B) due to brake dragging.

- If one or more of conditions specified below is found, it indicates a brake dragging concern and the affected side caliper is defective. Go to Step 7.
- If the disc plates are in normal condition, the problem does not exist. This Service Information is not applicable.

NOTE: If the disc plate(s) / brake pads are damaged, inspect and replace the affected side(s) as necessary according to the instructions on MGSS online:

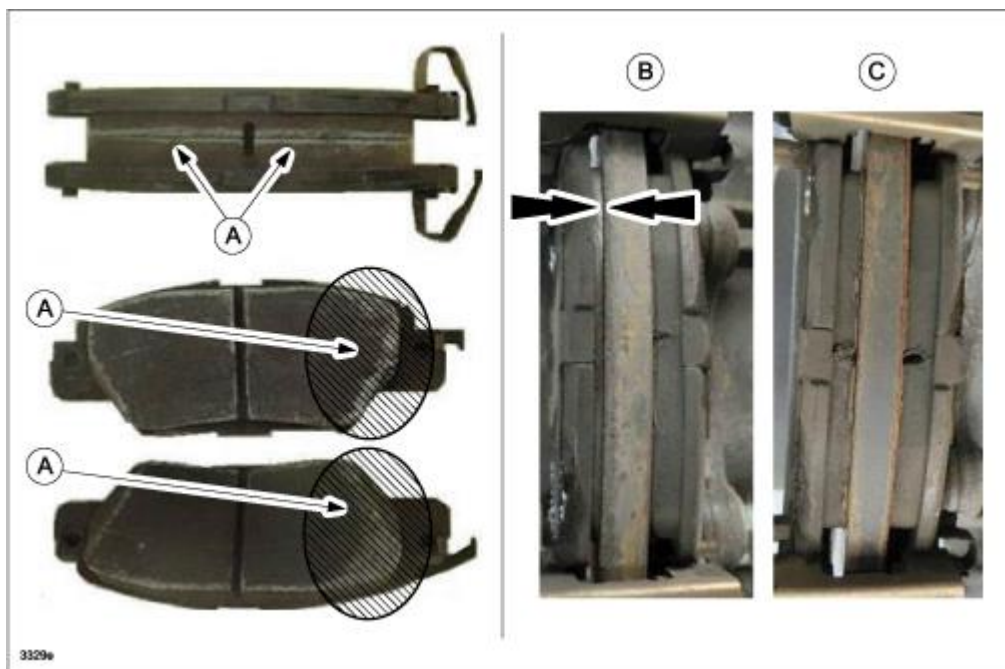
BRAKE PAD INSPECTION

6. Inspect the brake pads for whitened by heat (A) or abnormal wear on only the outer pad (B) due to brake dragging.

- If one or more of conditions specified is found, it indicates a brake dragging concern and the affected side caliper is defective. Go to Step 7.
- If the brake pads are in normal condition, the problem does not exist. This Service Information is not applicable.

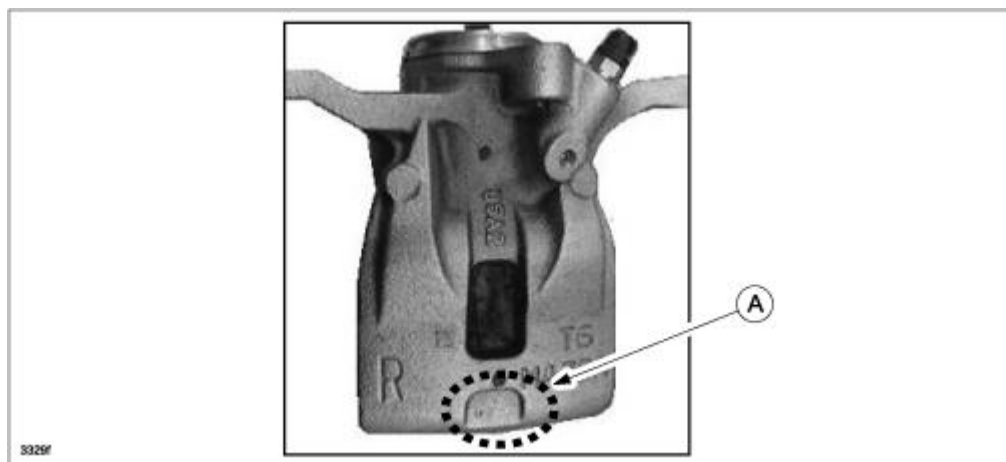
NOTE: Part numbers of caliper have not been changed by this modification. Distinguish the modified one from old one using the 3-digit lot number (Production Date) stamped on the caliper (A).

Calipers with the lot number (production date) of **697 (2016/09/07)** and higher are modified.
